Improving Water Quality by Improving Watershed Health

The Swift Current Creek Watershed Stewards

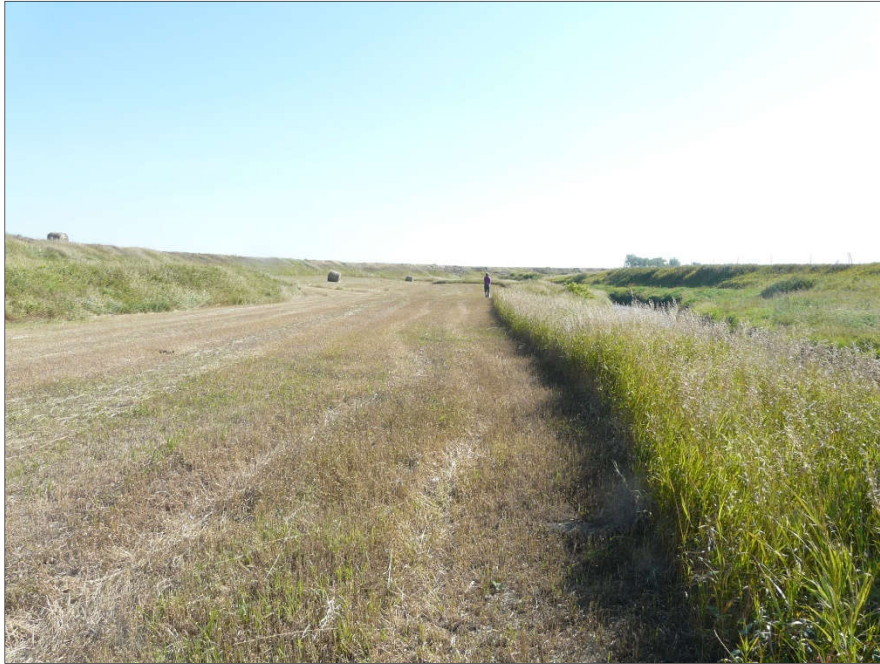
Figure 5. Walking and measuring the 200 m reach at site K76

All RHAs were completed in late August of 2018. At each of the four monitoring sites a 200 m reach was determined 100 m upstream and 100 m downstream of the site hub. The 200 m reach was measured using a Westward® 100 m/330 ft. measuring tape. RHAs were conducted by walking the entirety of the sample reach and noting plant species, densities, woody species, evidence of erosion, bare ground, alterations, and the condition of the creek banks as according to the field workbook. Scores were then totalled at the end of the reach walk and then converted

to percentages to classify the reach as healthy, healthy with problems, or unhealthy. Picture documentation was also a part of the RHAs, as seen in Figure 5.

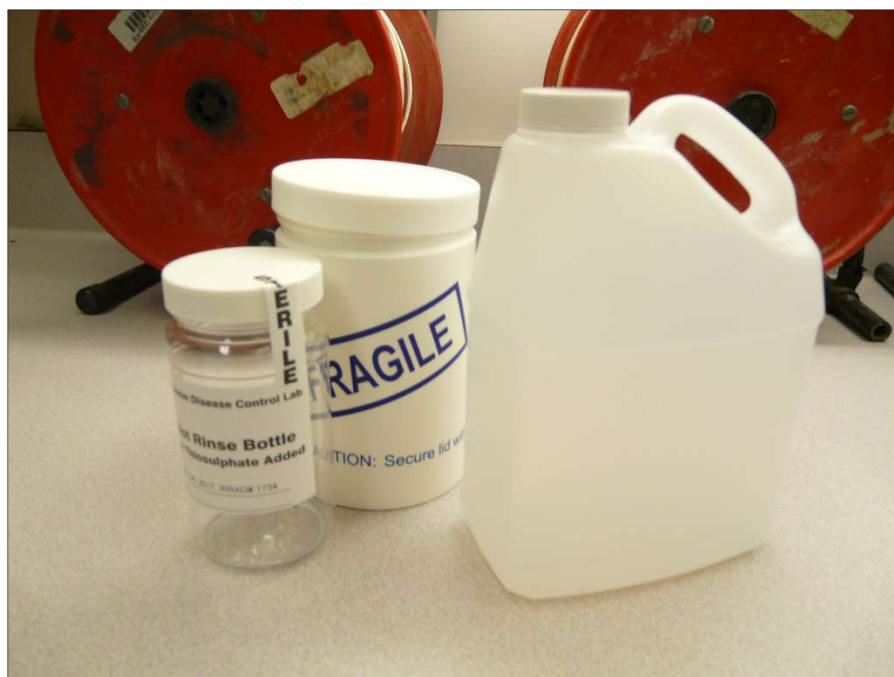
Figure 6. Sample bottles provided by the Roy Romanow Provincial Lab

Samples were collected using standard grab sample protocol. Two types of sampling containers were used: a 1-Litre plastic and a preserved sterile bacteria sample bottle, as seen in Figure 6. These were provided by the Provincial Disease Control Laboratory (now the Roy Romanow Provincial Laboratory) in Regina, SK. Samples were taken at the site hub by wading into the center of the creek flow. The collector faced upstream to avoid debris entering the sample bottle. For the non-sterile samples, the bottle was partially filled, capped, shaken, and discarded downstream for a total of three times to thoroughly rinse the bottle. The final sample was taken by filling the bottle approximately 20 cm below the surface and then capped securely underwater. Bacteria sampling was done with a partial sample from the 1 L bottle, without any rinsing due to the preservative already contained. The collector was careful not to touch the inside of either bottle or caps to avoid contamination, especially with the sterilized bacteria bottle. Bacteria samples were placed in a protective container after being securely capped for shipping. Both samples from each site were placed in large Ziploc® bags labelled with time,

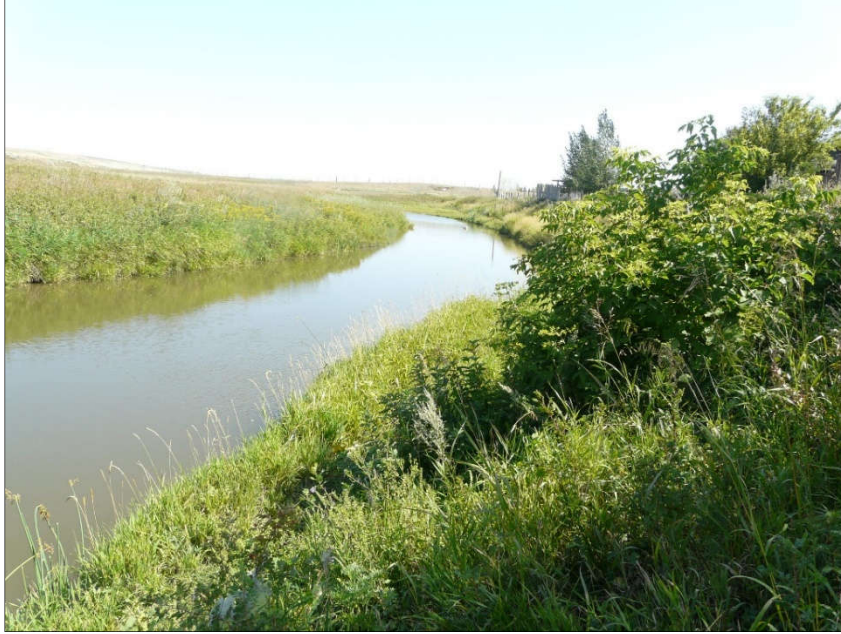
Figure 7. Site D70 facing downstream at the center of the 200 m assessment reach

the WWTP. This site in the past, as well as presently, has had issues with lateral cutting, a partially decommissioned low-level crossing, culvert installation, and unstable banks and erosion. These issues all occur just upstream of the reach assessed in 2017 and 2018 but were likely included in the reaches assessed in 2004 and 2013. A small number of horses are present and often cross the creek into adjacent pastureland in a shallow crossing area downstream in the reach. Corrals and open access for horses are also located near the downstream end of the reach. The site was assessed on August 22, 2018. Figures 7 and 8 following show the upstream and downstream view of the 200 m reach assessed in 2018.

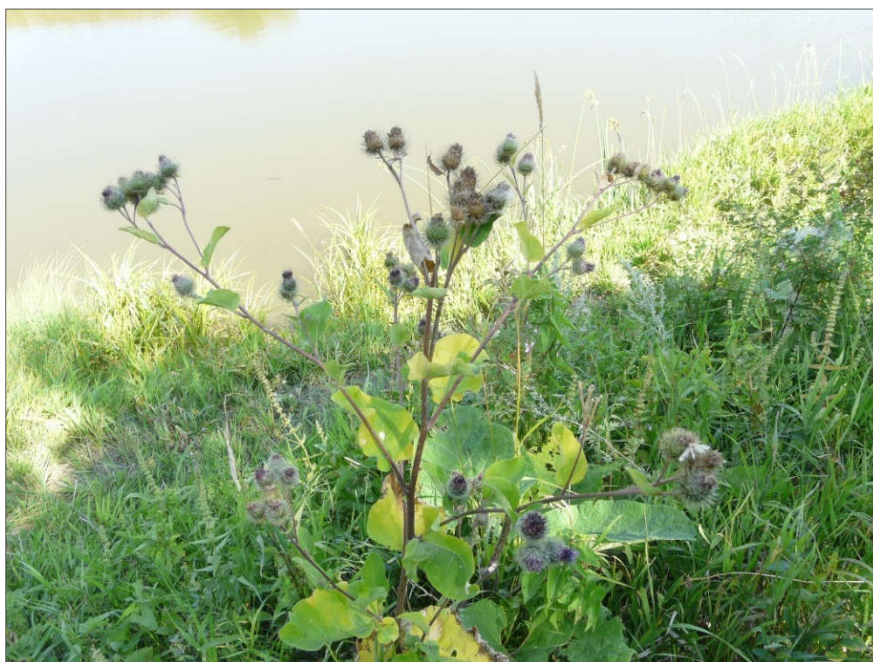
Figure 9. Common Burdock at site D70

- Continued erosion and invasion of unwanted plants seem to be in a continuing trend, limited the biodiversity especially at site I80.
- New and increasing invasive species found at site D70 were Common Tansy and Common Burdock. Burdock was also common in the city upstream so it is moving downstream.

- Due to the dry years many disturbance plants such as Kochia were present in more abundance due to their adaptation to dry conditions.
- Drought conditions can not be mitigated, but suppression of the common tansy and burdock can help slow the spread of these invasives.

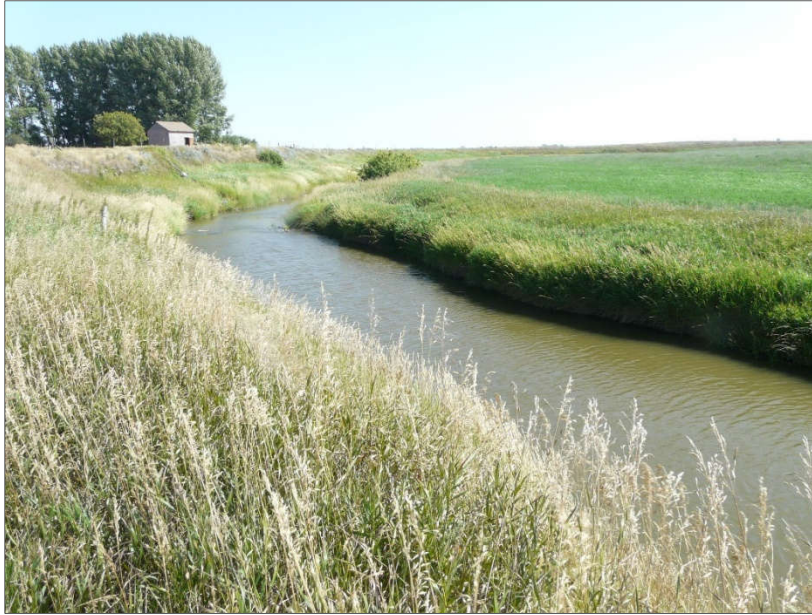
Figure 11. The downstream view of site J73

The overall comparison of scores between 2006 and 2018 do suggest that this site has degraded enough to put it close, but not quite, into the unhealthy category in 2018, with an overall score of 61%. In 2006 the score was in the healthy with problems category with a 68% score. It is apparent that the health of this site may be contributing to the downstream water quality due to the riparian not functioning at proper levels. Figures 11 and 12 show the downstream view of J73 and the vegetated cover of the banks.

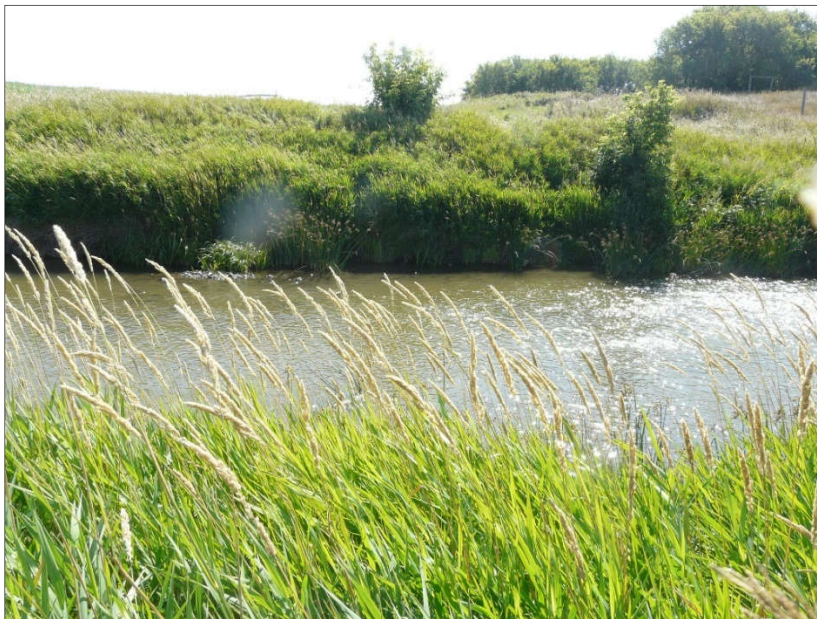
Figure 12. The east banks of site J73 are well vegetated right to the water's edge

Soils and hydrology scores ranged similarly between 2006 and 2018. In 2006 the site was given a rating of 75%. In 2018 the rating was given at 73%. Vegetated cover is good at this site and active lateral cutting was observed in portions of the reach. Banks are steep on both east and west banks and minimal floodplain was observed in 2006 on inside meanders (Hansen 2006). The

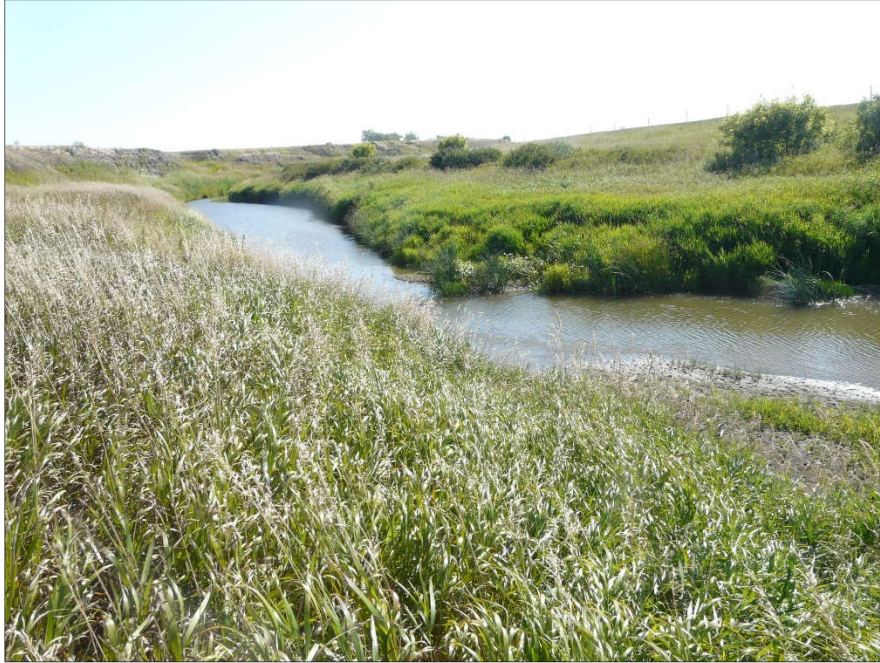
Figure 14. Site K76 view downstream with steep banks towards the northeast

The soils score in 2018 rated at 66%, falling within a healthy with problems category. In 2006 this site also rated within this category at 72%. The lower score in 2018 compared to 2006 indicates that this site may be degrading in riparian function. Desirable and woody species to improve bank stability, root binding, and erosion prevention were not present. This site shows lateral cutting, steep bare banks, and vegetative cover is not well established in various points along the reach. Channel incisement was rated at a Stage 3 in both 2006 and 2018, which indicates moderate incisement and 1-2 year flows may not be able to access the floodplain. In Figures 13 and 14 it can be seen both in the upstream and downstream views the steepness of the banks along this riparian reach.

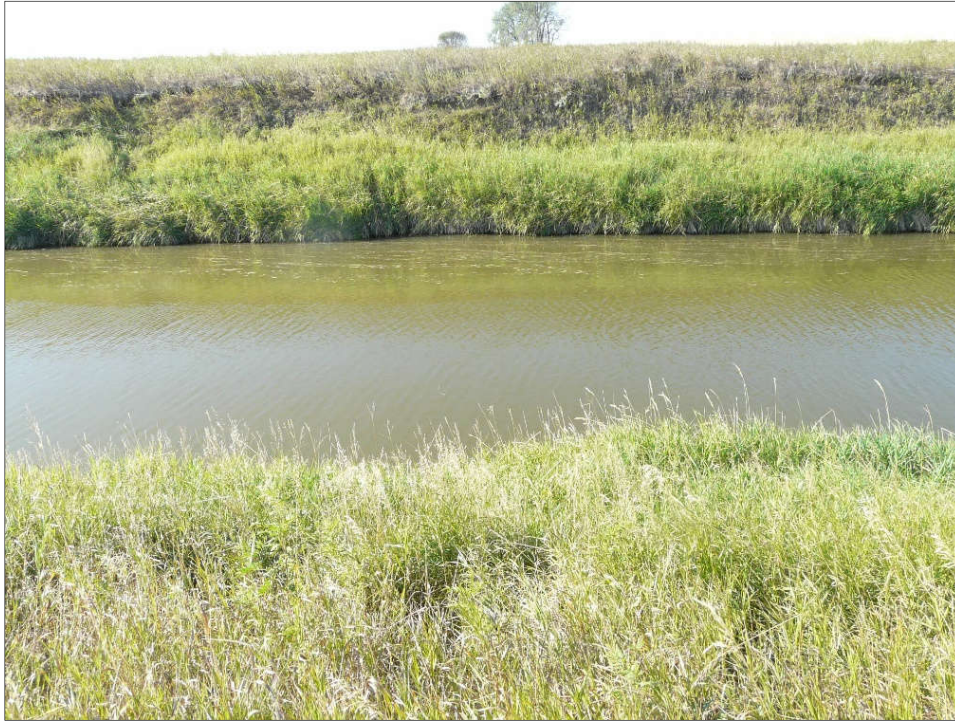
Figure 15. South banks vegetated but slumping due to lack of root binding vegetation

Soils and hydrology scored 70% as there was minimal human caused bare ground and active lateral cutting in close proximity to the creek. The most significant land use is annual crop land above the riparian buffer on the north bank. The land alteration by human activity had the lowest possible score. This upland use could also pose a problem in the potential for agricultural run-off and flooding. The channel is moderately incised and the 1-2-year flow may not be able to access the floodplain.

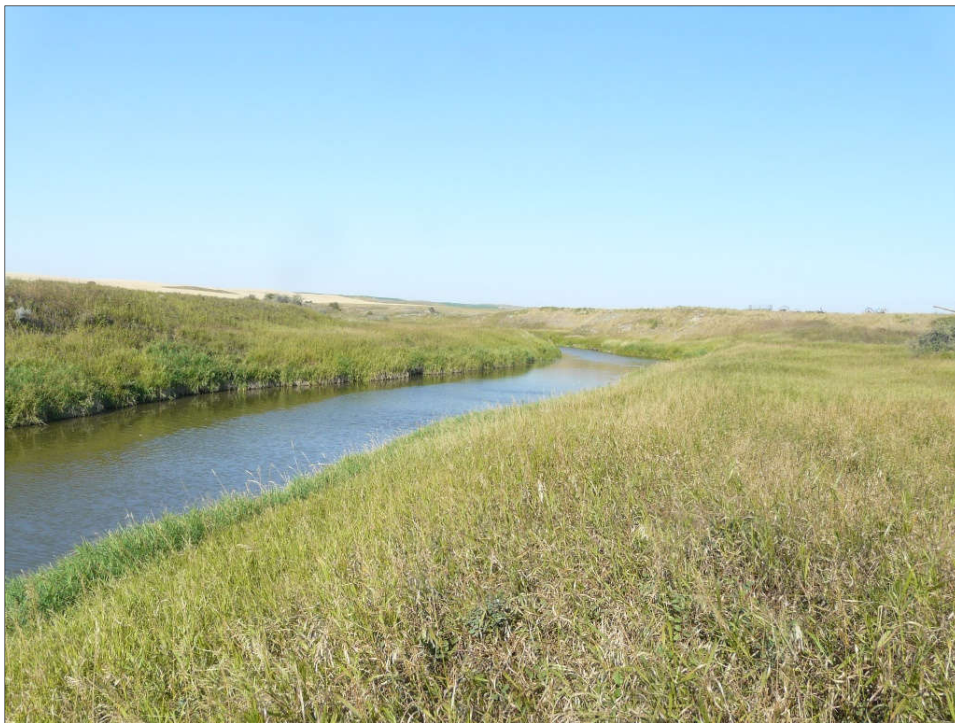
Figure 16. Minimal riparian vegetation adjacent to cropland

Overall this new reach of Site I80 scored 57% which rates it as unhealthy, which was the same range as 2017. This is due to the dominating presence of invasive and disturbance increaser vegetation which lack deep roots and soil binding capabilities along the banks. There was also a lack of preferred trees and shrubs including regeneration of these species observed. It is apparent that the further downstream of the four monitoring sites the RHAs declined. This may help indicate that water quality has been negatively affected by lack of proper functioning riparian

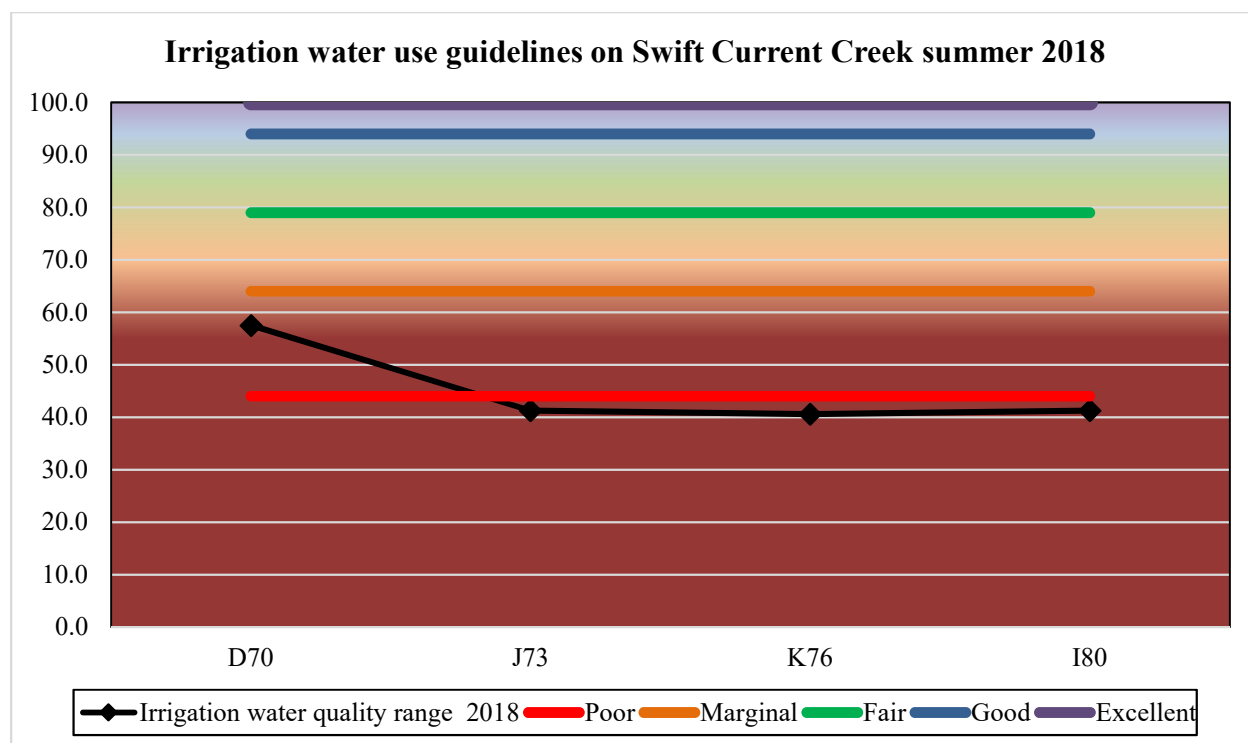
Figure 17. Irrigation water use guidelines on Swift Current Creek summer 2018

The Saskatchewan Environment 2006 guidelines for irrigation water use can be found in Table 9 and the 2006 calculated indices scores can be seen in Figure 17. Index percentage scores ranged from the lower 40% with the lowest taken at site K76 with 40.6%. Sites J73 and I80 both scored 41.3%. Site D70 had the best overall score at 57.7%. All sites with the exception of D70 are in the poor range of irrigation water use quality. In 2017 site D70 also scored in the marginal range as it did again in 2018. Site I80 remained in the poor range through 2017 to 2018.

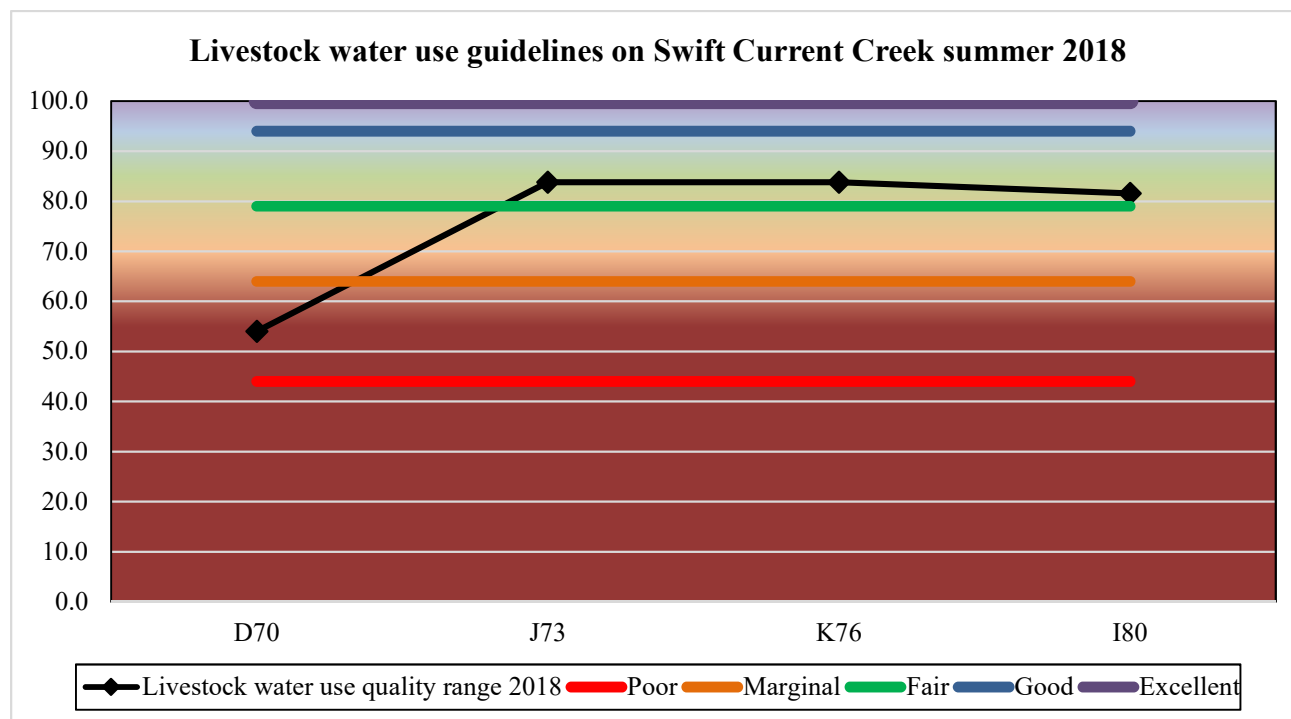
Figure 18. Livestock water use guidelines on Swift Current Creek summer 2018

Site I80 again showed the highest in amounts of sulfate every month sampled. Aluminum was the highest at site K76 for June, July, and August, with D70 taking a higher value in September at 198 µg/L. The highest aluminum levels were at site K76 in the month of August at 494 µg/L. In 2017 the general trend of livestock watering gradually deteriorated after site D70. In 2018 the data shows that the scores actually increase after site D70. The scores do, however, indicate that issues are present with the quality of water to livestock in this area, and the hot dry summer may be contributed to increased levels of Total Dissolved Solids (TDS) in the SCC in 2017.

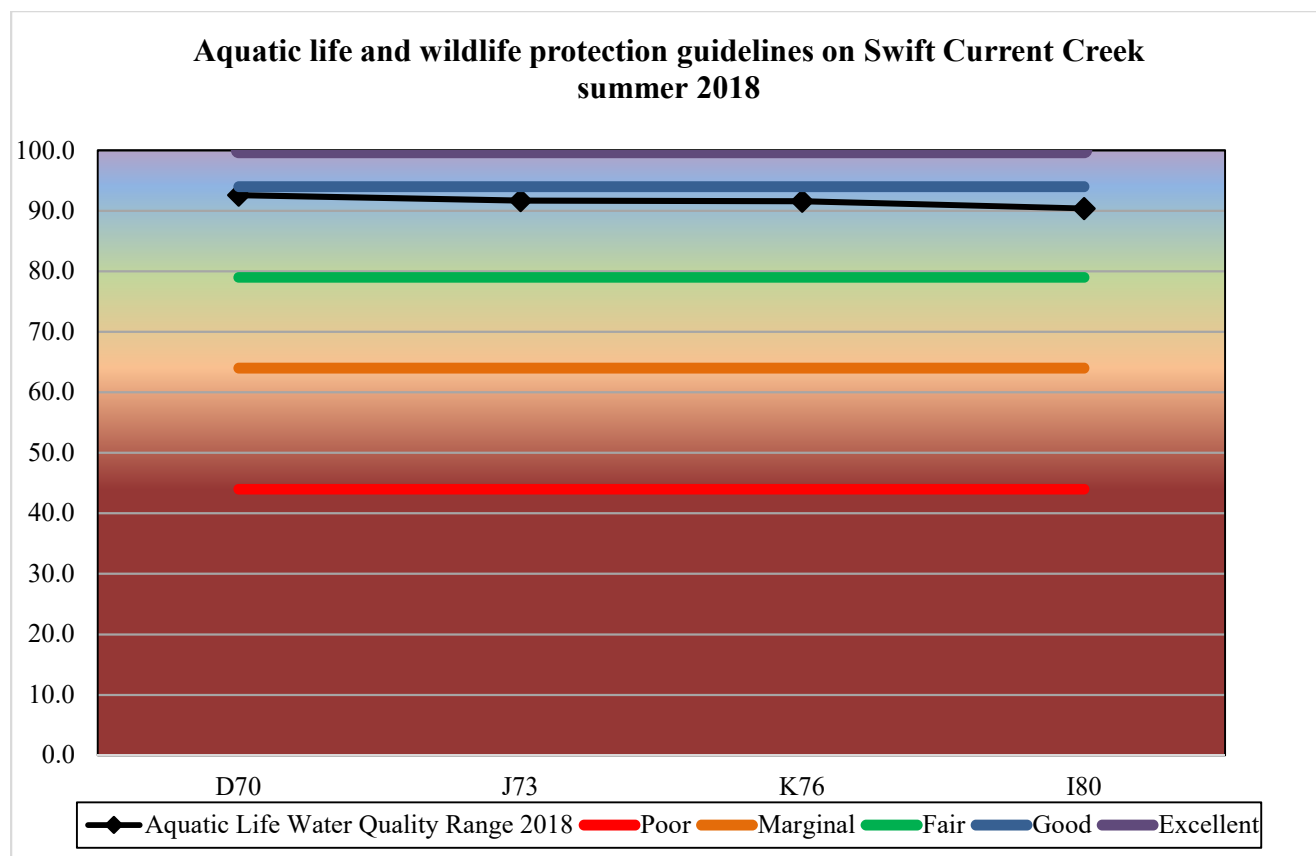
Figure 19. Aquatic life and wildlife protection guidelines on Swift Current Creek 2018

Mercury is a difficult measure and though the set limit is <0.026 µg/L, the lab results can at best only show values < or > 0.04 µg/L. This still puts mercury above the 2006 guidelines, and a severe outlier occurred at site J73 in the month of July at 52.4 µg/L. Despite this oddity, all sites rated in the good ranges. A slight decline was observed at site K76 and towards I80. Site D70 had the highest score of 92.6%, which is an increase from the fair rating it received in 2017. Site I80 also saw a significant decline in 2017 and again in 2018 it showed the lowest score at 90.4%. Figure 19 shows the rated indices from 2018. The 2015 guidelines were not significantly changed therefore are not compared to the 2006 guidelines.

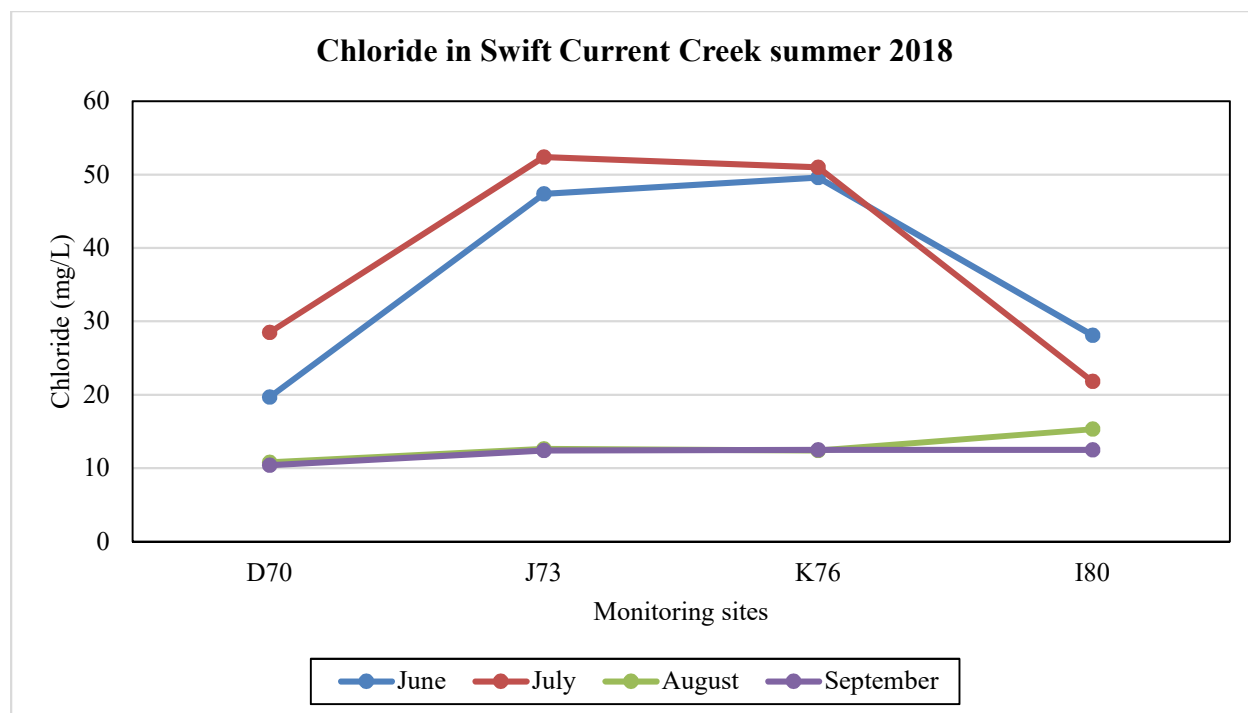
Figure 21. Chloride in Swift Current Creek summer 2018.

In 2018 similar results were recorded, with the highest levels of chloride at site J73 in July. This site is the first site downstream of site D70, which also had high levels of chloride in 2017. The highest level recorded in 2018 was 52.4 mg/L, which is still under the maximum acceptable limit of 100mg/L. Figure 21 shows that the highest levels were consistent between sites D70 and I80 at J73 and K76. The months of June and July showed the highest levels which maybe due to the saline areas surrounding those two sites.

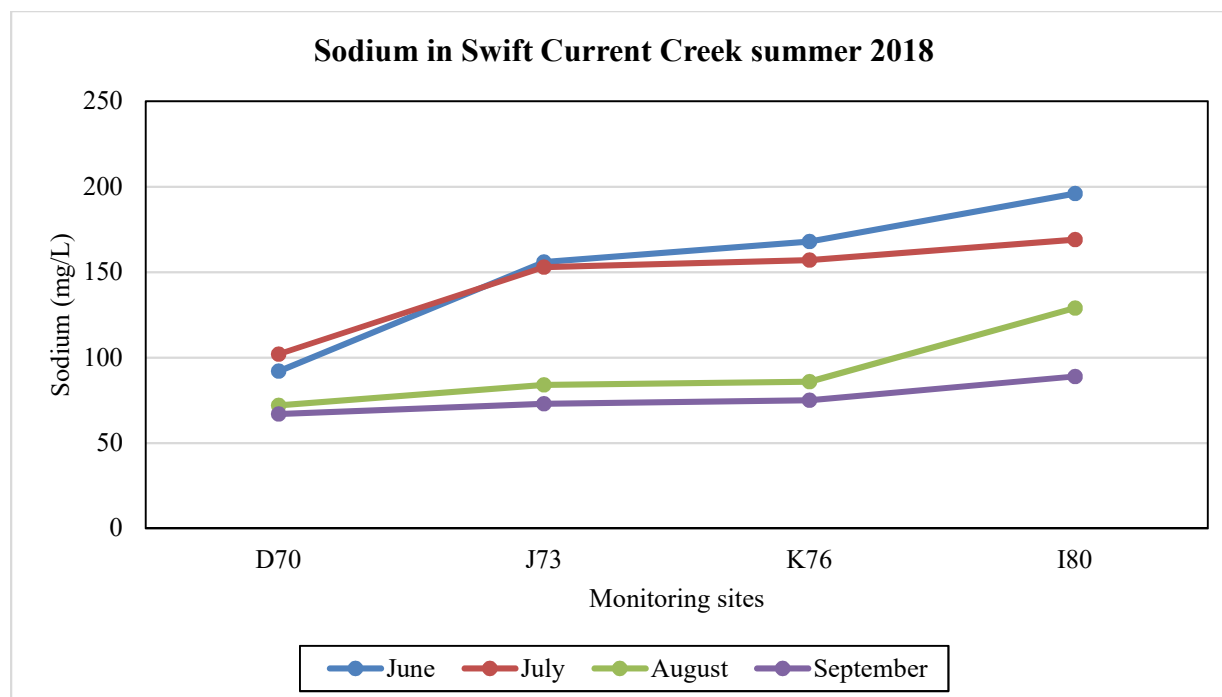
Figure 22. Sodium levels in Swift Current Creek summer 2018

Sodium levels do show a gradual increase from site D70 through to site I80. The sites of J73 and K76 show a plateau of values before increasing again at site I80. In 2017 the highest recorded levels of sodium that were over the guidelines occurred at sites D70, I80, and the furthest downstream site of E90. In 2018 the highest level was observed at site I80 at 196mg/L in the month of June. Site D70 had the lowest concentrations of sodium and with the exception of July at 102mg/L, all values remained under the acceptable levels. Levels at sites J73 and K76 were less than that of site I80, but were over the maximum acceptable limits in June and July by a large factor. This pattern can be seen in Figure 22.

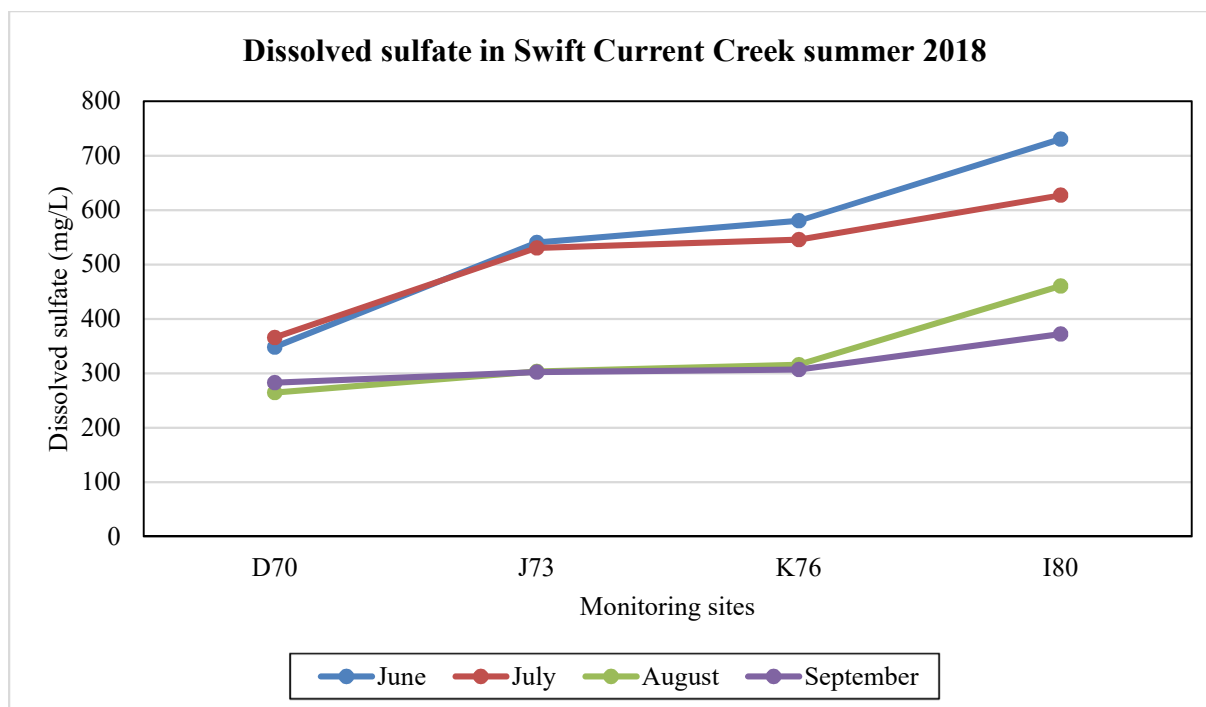
Figure 23. Sulfate in Swift Current Creek summer 2018

In 2017 the highest concentration of sulfate was taken from site I80 in July at 967 mg/L. No other samples taken in 2017 were as close to 1000mg/L as site I80, and livestock watering may have caused issues with the high sulfate levels. Site D70 had concentration higher than the 500mg/L limit in both June and July, while site I80 was over the limits during every month of sampling. In 2018 site I80 once again showed the highest concentrations with the highest recorded in June at 730.5 mg/L. Site D70 had the lowest concentrations and sites J73 and K76 were both significantly higher in June and July then August and September. Figure 23 shows the increases in sulfate from site D70 to I80.

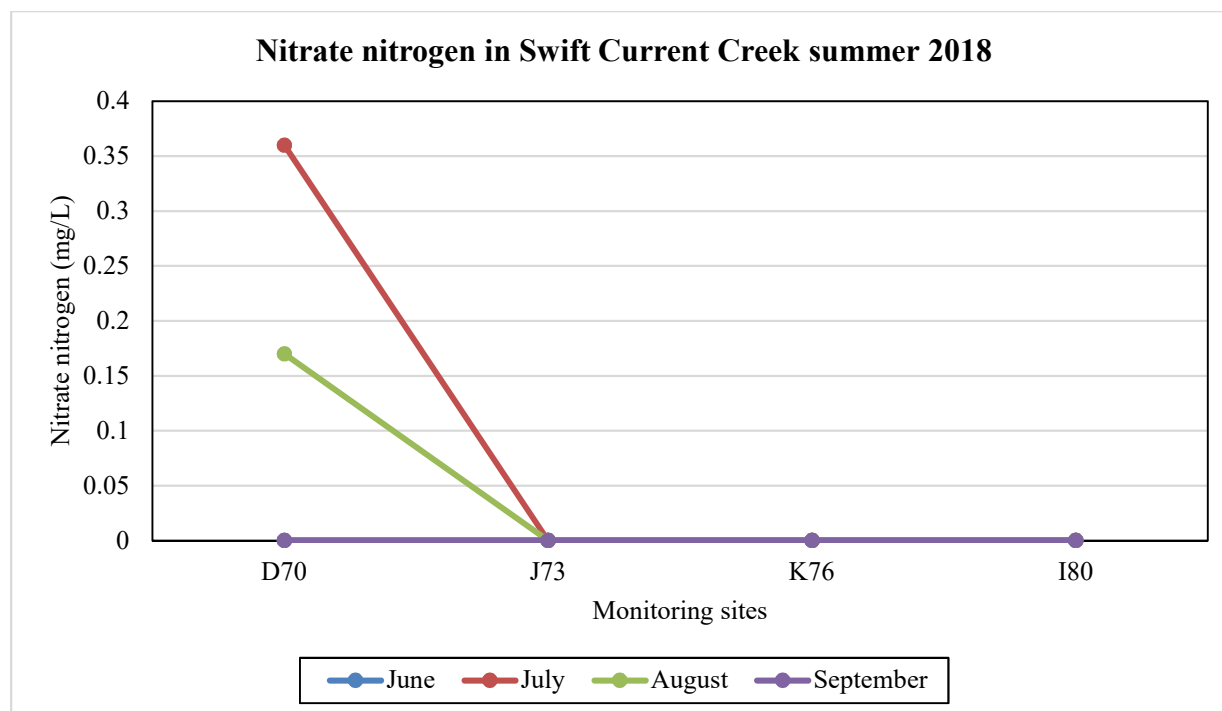
Figure 24. Nitrate nitrogen in Swift Current Creek summer 2018

General water quality has a limit of nitrite nitrate nitrogen set at 1mg/L. Ammonia as nitrogen falls under the aquatic life and wildlife index but must be calculated according to temperature and pH. In the 2017 results site D70 was the only site identified downstream with high levels of nitrite nitrate nitrogen. In 2018 the results showed the same pattern as site D70 had all of the highest concentrations and levels dropped significantly at site J73. Though site D70 had the highest levels none exceeded the 1.0mg/L limit, with the highest reaching 0.36 mg/L in July and the remaining sites at <0.04 mg/L (shown in Figure 24).

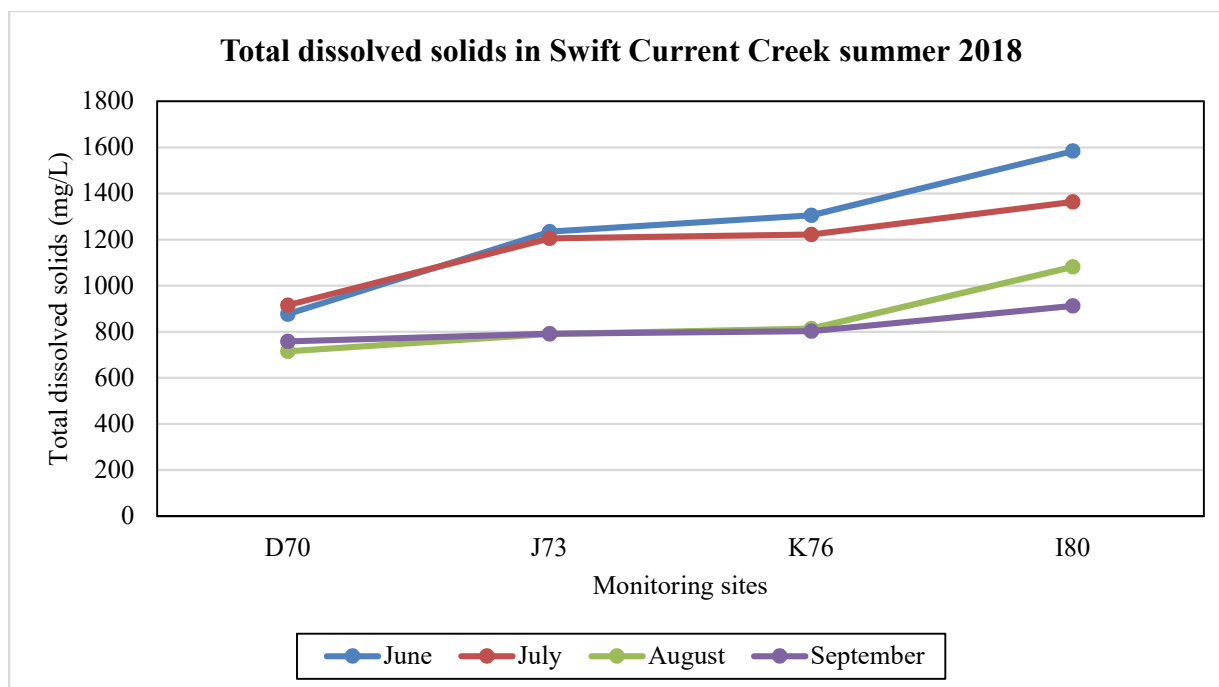
Figure 25. Total Dissolved Solids in Swift Current Creek summer 2018

Human-caused contributors to TDS include agricultural run-off and municipal and industrial discharges and even though TDS levels are not an immediate health risk to human consumption, the Saskatchewan Ministry of Environment Drinking Water Quality Standards have an aesthetic limit of 1500mg/L (SaskH₂O 2008). Aesthetic appearance, odor, and taste are categorized under this limit. In 2015 WSA issued new limits for TDS for livestock watering to 3000mg/L from 1000mg/L, as high TDS can be fatal in livestock (SCCWS 2018). Once again site I80 showed some of the highest TDS readings in 2017 occurring in July at a value of 1895mg/L. The irrigation index was also changed in 2015 from 700mg/L to a range of 500-3500mg/L depending on the crop being irrigated (SCCWS 2018). In 2018 site D70 consistently stayed as the lowest value, all reading under 1000mg/L. Sites J73 and K76 gradually increased moving downstream to site I80, which had the highest reading in June at 1584 mg/L. While this value is the highest, all remain within the set limits of the indices, as shown in Figure 25.

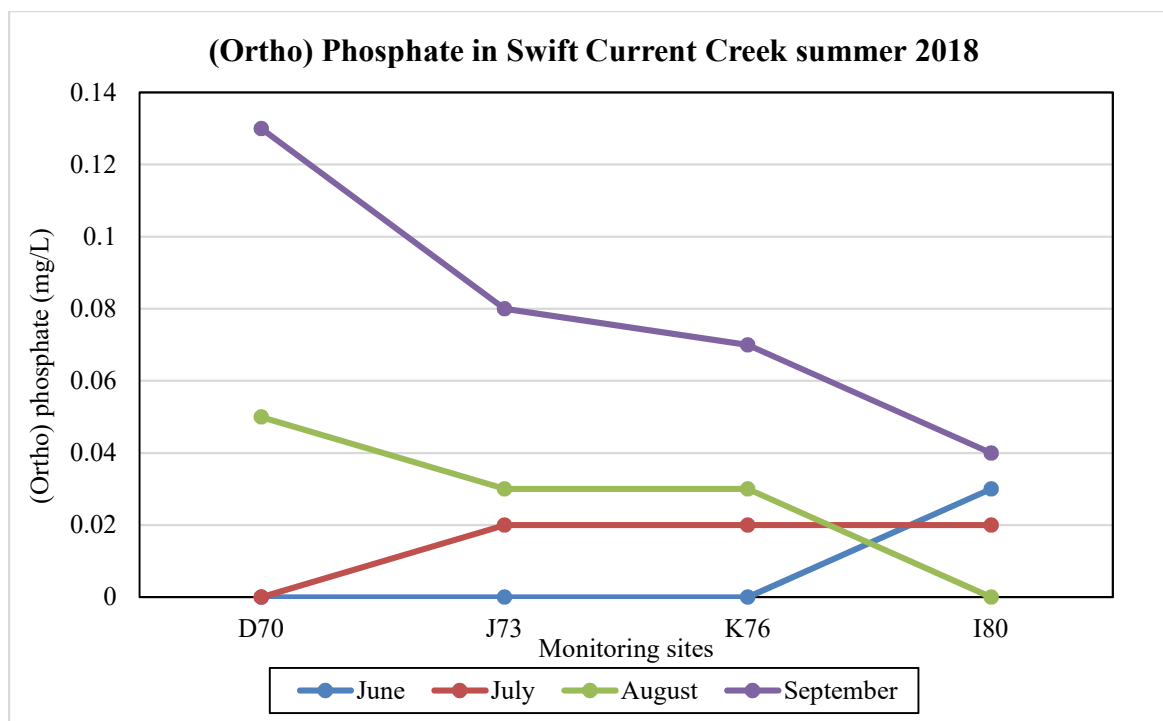
Figure 26. Orthophosphate in Swift Current Creek summer 2018

One issue that orthophosphate can cause is algal blooms, especially the toxic blue-green algae (cyanobacteria) which can be fatal to aquatic life and also livestock that consume the water (Murphy 2007 as cited by SCCWS 2008). The maximum level of orthophosphate in the general water quality index is 0.1 mg/L. Sites upstream of the city of Swift Current showed higher levels than the limit, and downstream sites such as D70 and I80 showed lower results. The 2018 data show similar results with no levels at the maximum limit. The highest reading was taken at site D70 in September at 0.13 mg/L. If any increases occurred it was often started at site J73 and towards sites K76 and I80, and the highest values were recorded in the month of September (Figure 26). The lowest levels were recorded in June, with increases at site I80 from site K76 which was <0.02 mg/L to 0.03 mg/L.

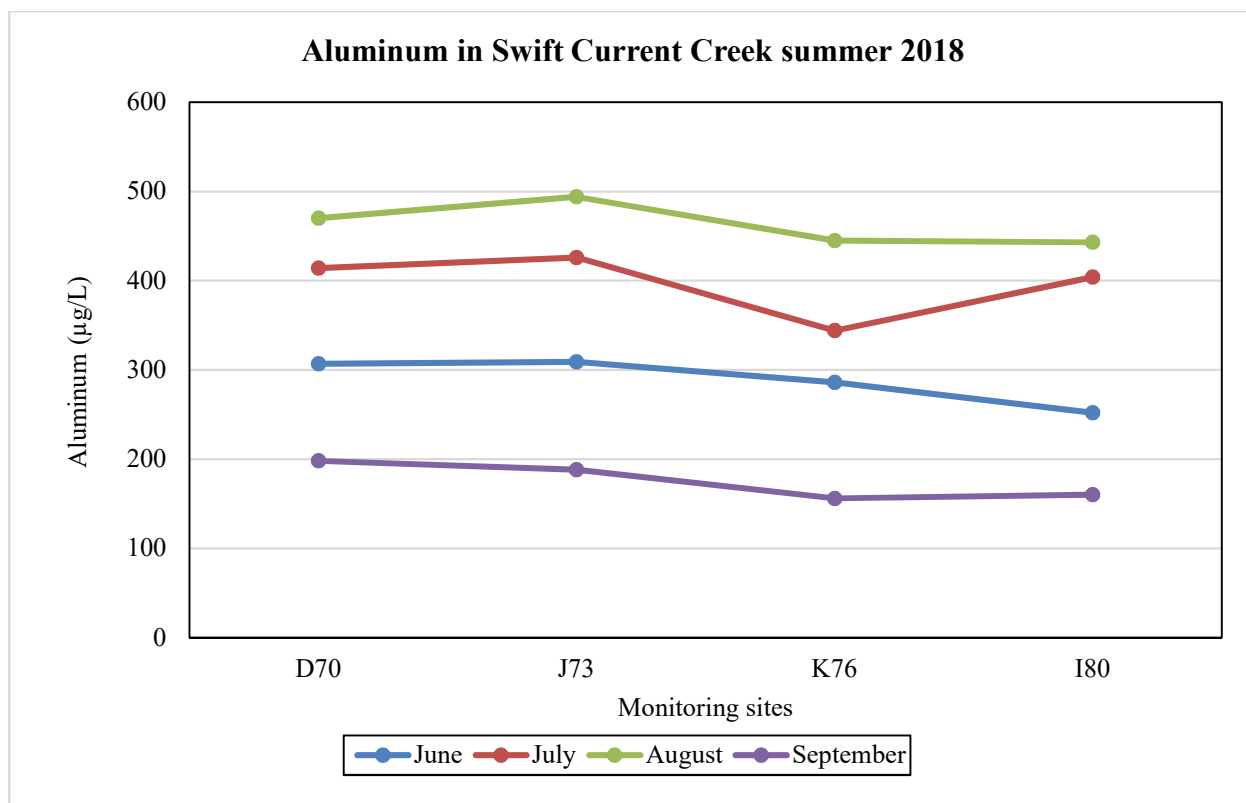
Figure 27. Aluminum in Swift Current Creek summer 2018

General water quality has a limit of 5mg/L or 5000 µg/L. Concentrations were expected to be higher at the city sites and downstream in 2017, which they proved to be. However, aluminum also tested high upstream of the city of Swift Current. No values in 2017 were over the limit and the highest concentration was documented at site I80 in May at 4.22 8mg/L. In 2018 the sites showing the highest concentrations of aluminum are D70 and J73. The highest value was taken in August at site J73 with a concentration of 494 mg/L. As shown in Figure 27 aluminum levels stayed fairly consistent within the sampling areas and none were over the 5000 mg/L limit. For every month with the exception of July the concentration lowered between sites K76 and I80. As the sites are moving further downstream of the WTP and WWTP in Swift Current, it may suggest that the higher concentrations make sense coming directly downstream of the city at site D70 and gradually decreasing as the creek flows east towards Waldeck.

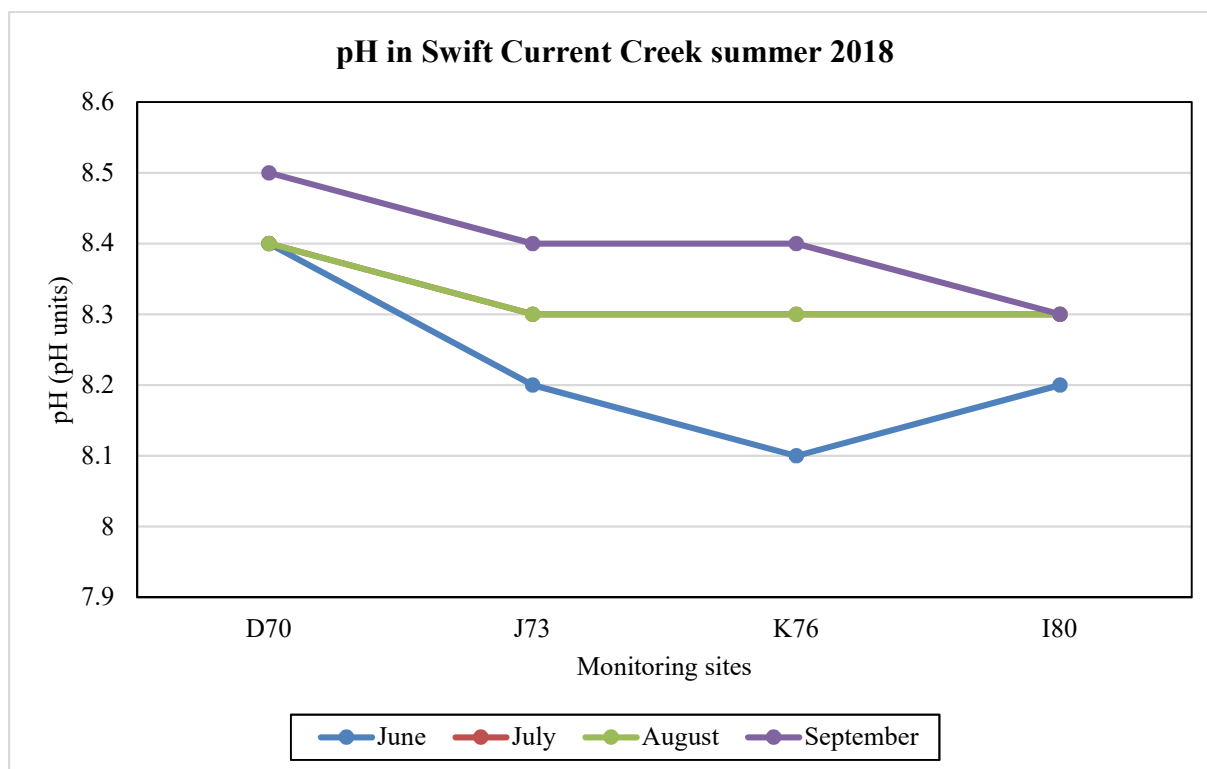
Figure 28. pH in Swift Current Creek summer 2018

In the southwest water naturally has a range of pH up to and including 9 pH units and the aquatic life has adapted to these levels (J-M Davies in email document to K Steinley dated June 11 2018 11:21 AM; unreferenced as cited by SCCWS 2018). There were no sites in 2017 or 2018 that showed limits exceeding or falling below the limits. Samples were also taken in the morning to ensure same day shipping, so pH levels may have been slightly higher due to the time of day than the normal average. No values exceeded over 8.5 pH units and none fell below 8.0 pH units. The highest recording was at site D70 in September at 8.5 pH units and the entire summer sampling range was consistent in the 8 pH unit range with no outliers. Figure 28 shows the pH levels from each site though the summer of 2018.

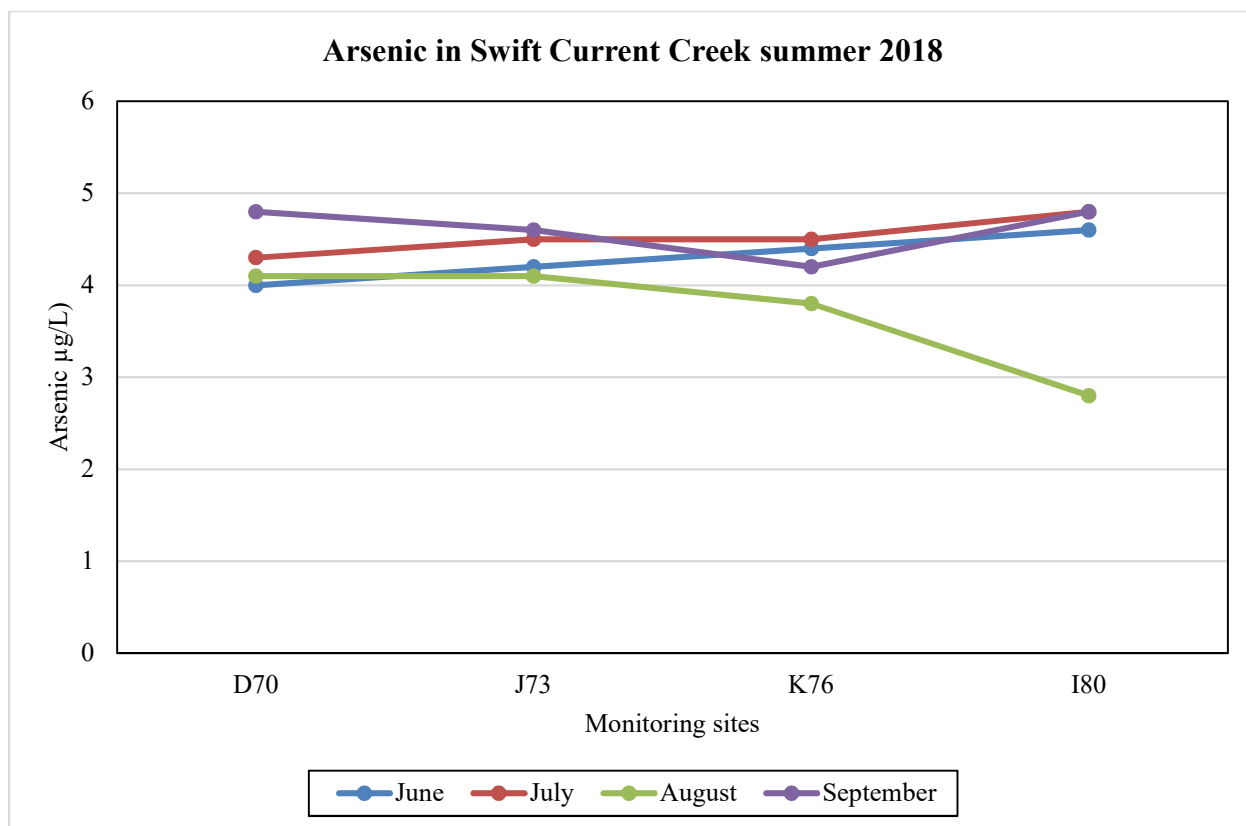
Figure 29. Arsenic in Swift Current Creek summer 2018

In 2018 no sites exceeded the 5 µg/L limit. However, close occurrences recorded in September at site D70 with a reading of 4.8 µg/L and also site I80 at 4.8 µg/L in both July and September. Sites J73 and K76 had a maximum of 4.6 µg/L also occur in September at site J73 specifically. All other values were 4.5 µg/L and below. The lowest arsenic value was taken at site I80 in August, just before the highest value peaked in September. This one occurrence at site I80 is much lower than the remaining summer test results, which were consistent in the 4.6-4.8 µg/L range, as shown in Figure 29.
