# Swift Current Creek Watershed Stewards Monitoring Project 2013

A Comparative Biomonitoring Assessment on the Macroinvertebrate Communities  
and Populations in Relation to the Operation of the Swift Current Waste Water  
Treatment Plant

Prepared for: The Swift Current Creek Watershed Stewards

November 29<sup>th</sup>, 2013

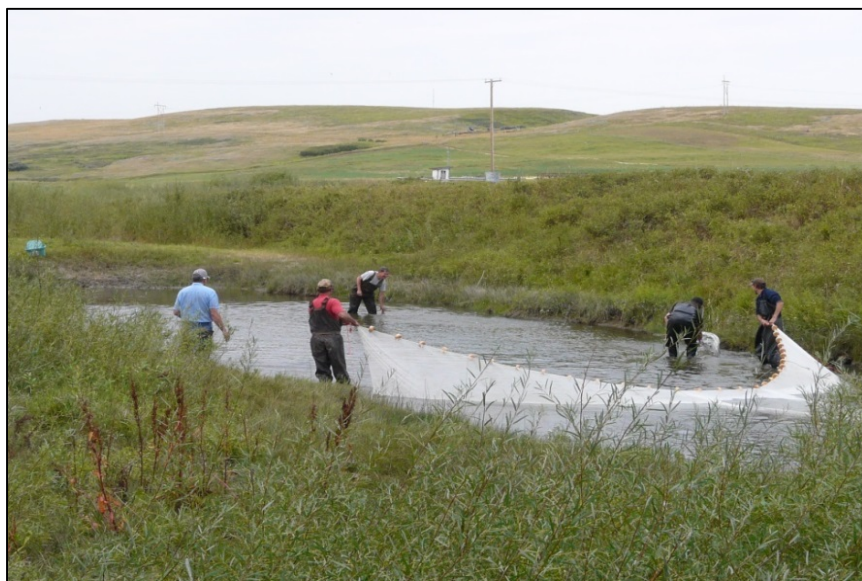
Figure 2- Seine sampling

At the end of the pull a person was waiting with a tub of water to collect the fish. The net would be pulled in together by the people walking towards each other and bringing the net together to avoid escapees. The net’s bag was then emptied into the tub sorting out any debris and unwanted catch such as crayfish (*Austropotamobius pallipes*). Crayfish must be removed quickly to avoid fish damage and death. Remaining crayfish were picked out of the net and returned to the creek.

Fish were then sorted into appropriately labelled 5-Gallon pails with water for population sampling or community sampling. Methods described here are shown in Figures 2 and 3.

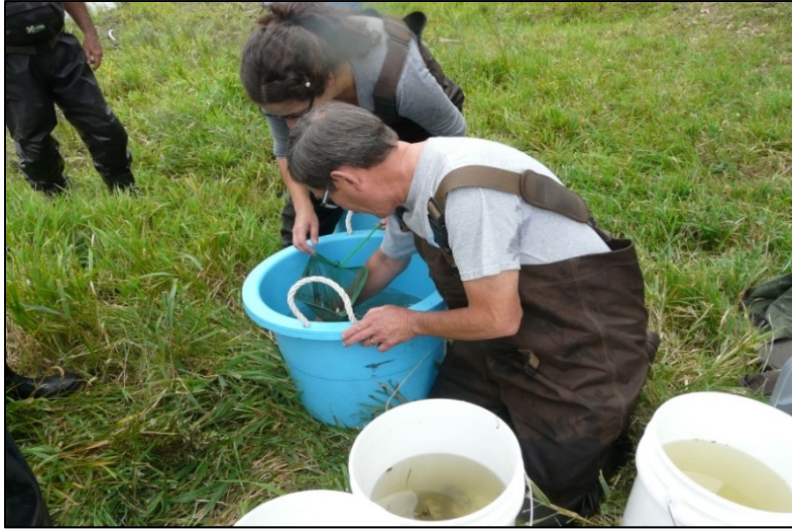
Figure 6- Sorting community species

Community species were identified to the genus species level and counted before being released.

A data sheet containing a list of all species was used to tally the numbers by a recorder. If new or rarely occurring species were found they were added to the list and photographs were taken for records. Community sampling can be seen in Figure 6 and white suckers ready for processing is shown in Figure 7.

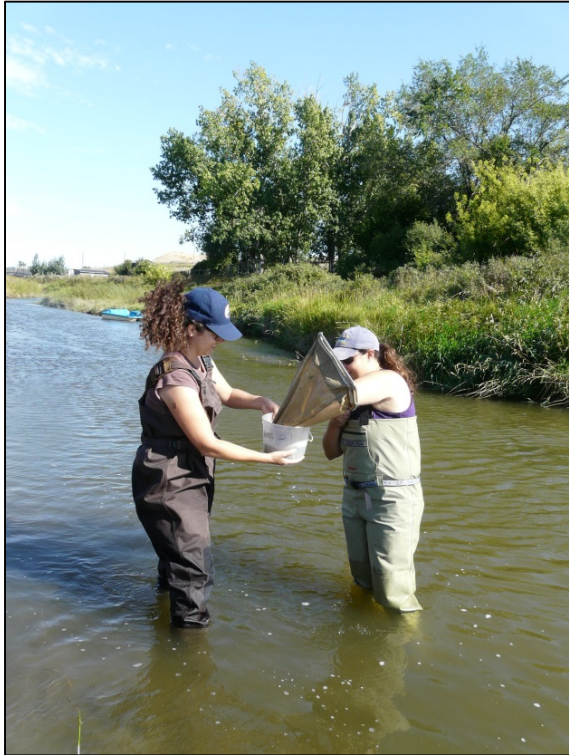
Figure 8- Integrating samples

*Saskatchewan Northern Great Plains Ecosystem Health Assessment Manual 2012: Version 1.0* prepared by Hoemsen (2012) obtained from MOE and WSA. Macroinvertebrates were collected within the same week and processed in the same manner. Transects started and ended at least 100 m away from any road crossing or bridge and were marked out four times, each 100 m apart from one another, totalling four transects or 400 m of sampling area. At each transect five subsamples were taken moving across the creek channel

perpendicular to the imaginary transect at right bank (1/5), right center (2/5), center (3/5), left center (4/5), and left bank. Samples were taken facing upstream and transect order was done beginning from downstream and working upstream.

All five subsamples were integrated into one sample per transect totaling four at each site, shown in Figure 8 above. The travelling kick and sweep method was used in conjunction with a conventional 30 cm base, 500  $\mu$ m mesh D-frame net to collect macroinvertebrates. This was done by a collector wading to the first point and setting the flat edge of the net on the creek bottom with the opening facing upstream. A timer would record for 10 seconds and the collector would shuffle and kick the sediment immediately in front of the net, overturning rocks and stirring up the bottom. Once 10 seconds were up the collector swept

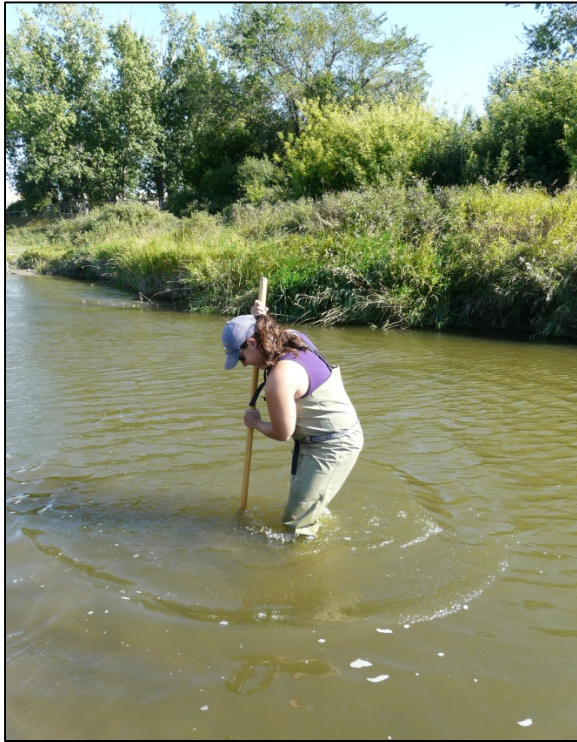
Figure 9- Travelling kick and sweep method

the net upwards into the current to prevent any escapees and empties into a 4-L plastic pail with lid and labelled with the transect number. Water splashed down the sides of the net helped rinse any attached organisms and thorough inspections were done after each sweep. The travelling kick and sweep method is shown in the following Figure 9.

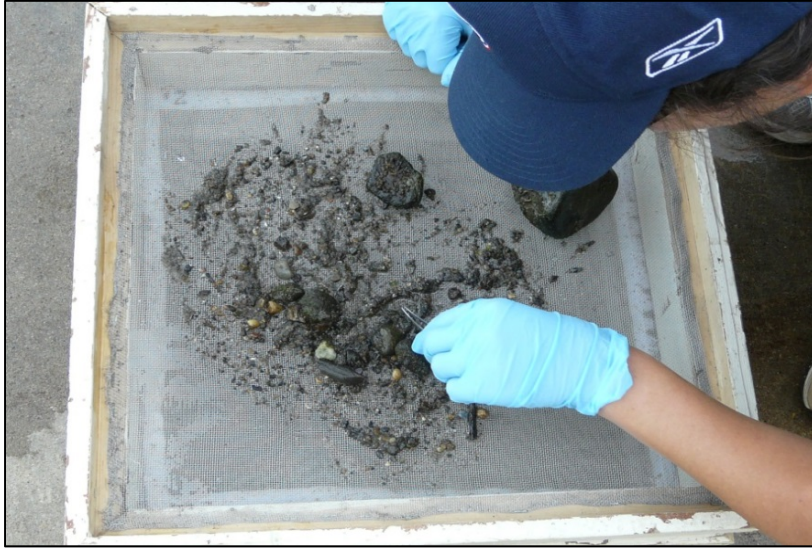
Figure 10- Sorting macroinvertebrates on screens

Macroinvertebrates were transferred to the Agriculture and Agri-Food Canada (AAFC) warehouse to be sorted and processed for shipping. Each transect pail was poured over a series of four 20''x20'' layered mesh sorting screens with the bottom being plywood. Screens varied from fine to coarse with sizes of 224, 272, and 625 squares per inch. A water hose was used to rinse the screens and deposit organisms and sediments according to size on the screens. Once

sorted, each screen was thoroughly inspected and all organisms were picked with forceps and placed in a labelled 1-L mason jar half full with 95% ethanol (ETOH) (Figures 10 and 11).

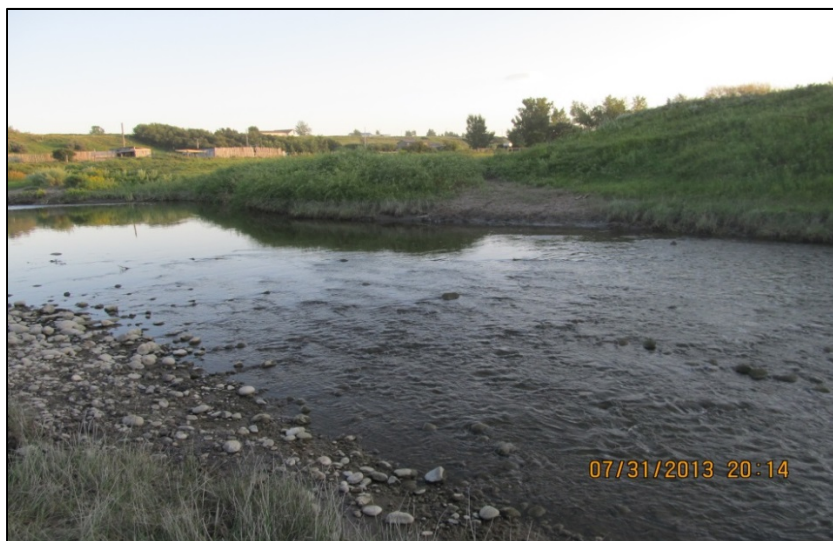
Soil and Hydrology ratings totalled 60 per cent. Horses use trails and low level crossings in the creek and there was extensive pugging and hummocking in these areas (Figures 12 and 13).

Figure 12- Low level crossing frequent by horses (Hansen 2013)

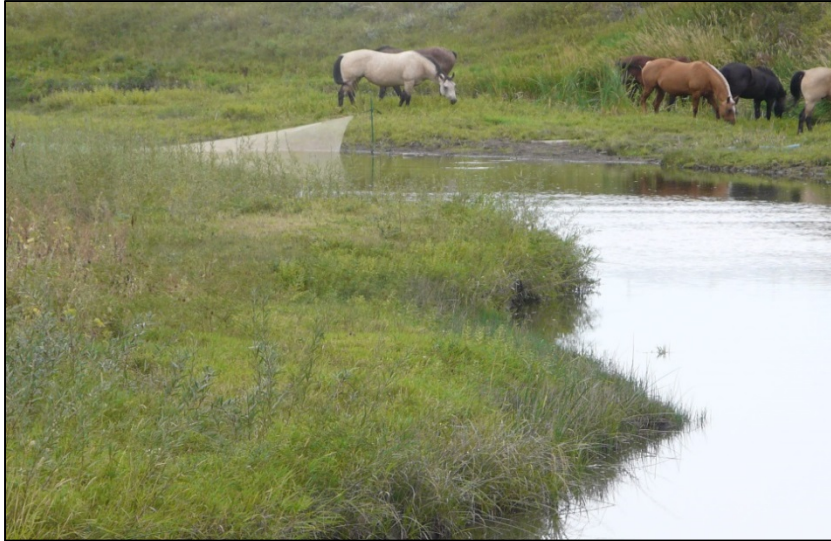
Figure 13- Horse activity at D-70

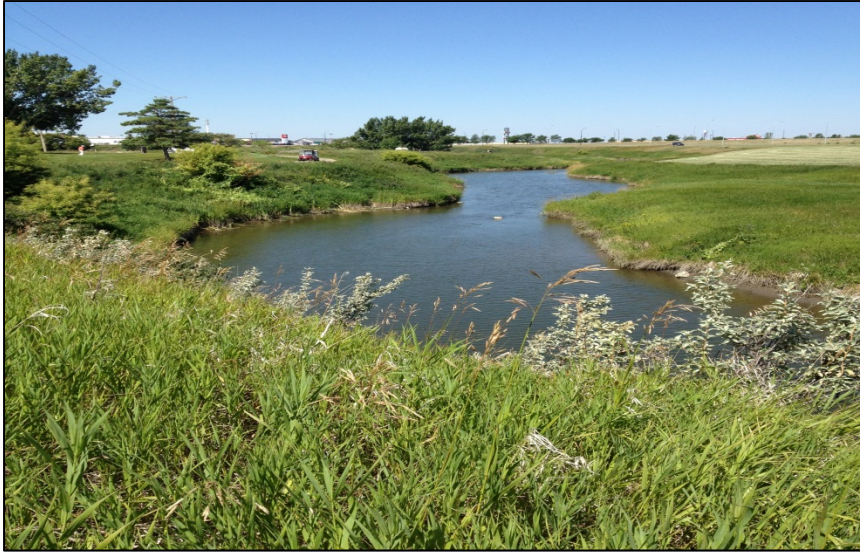
Site use varied greatly between sites D-70 and H-60. The primary bordering land use at H-60 is the Elmwood Golf course on the south side and mowed field on the north side. Vegetation rating totalled 73 per cent with good native species similar to D-70 (Hansen 2013). Figure 14 shows Site H-60.

Figure 14- Site H-60 showing vegetative cover and land uses on both banks (Hansen 2013)

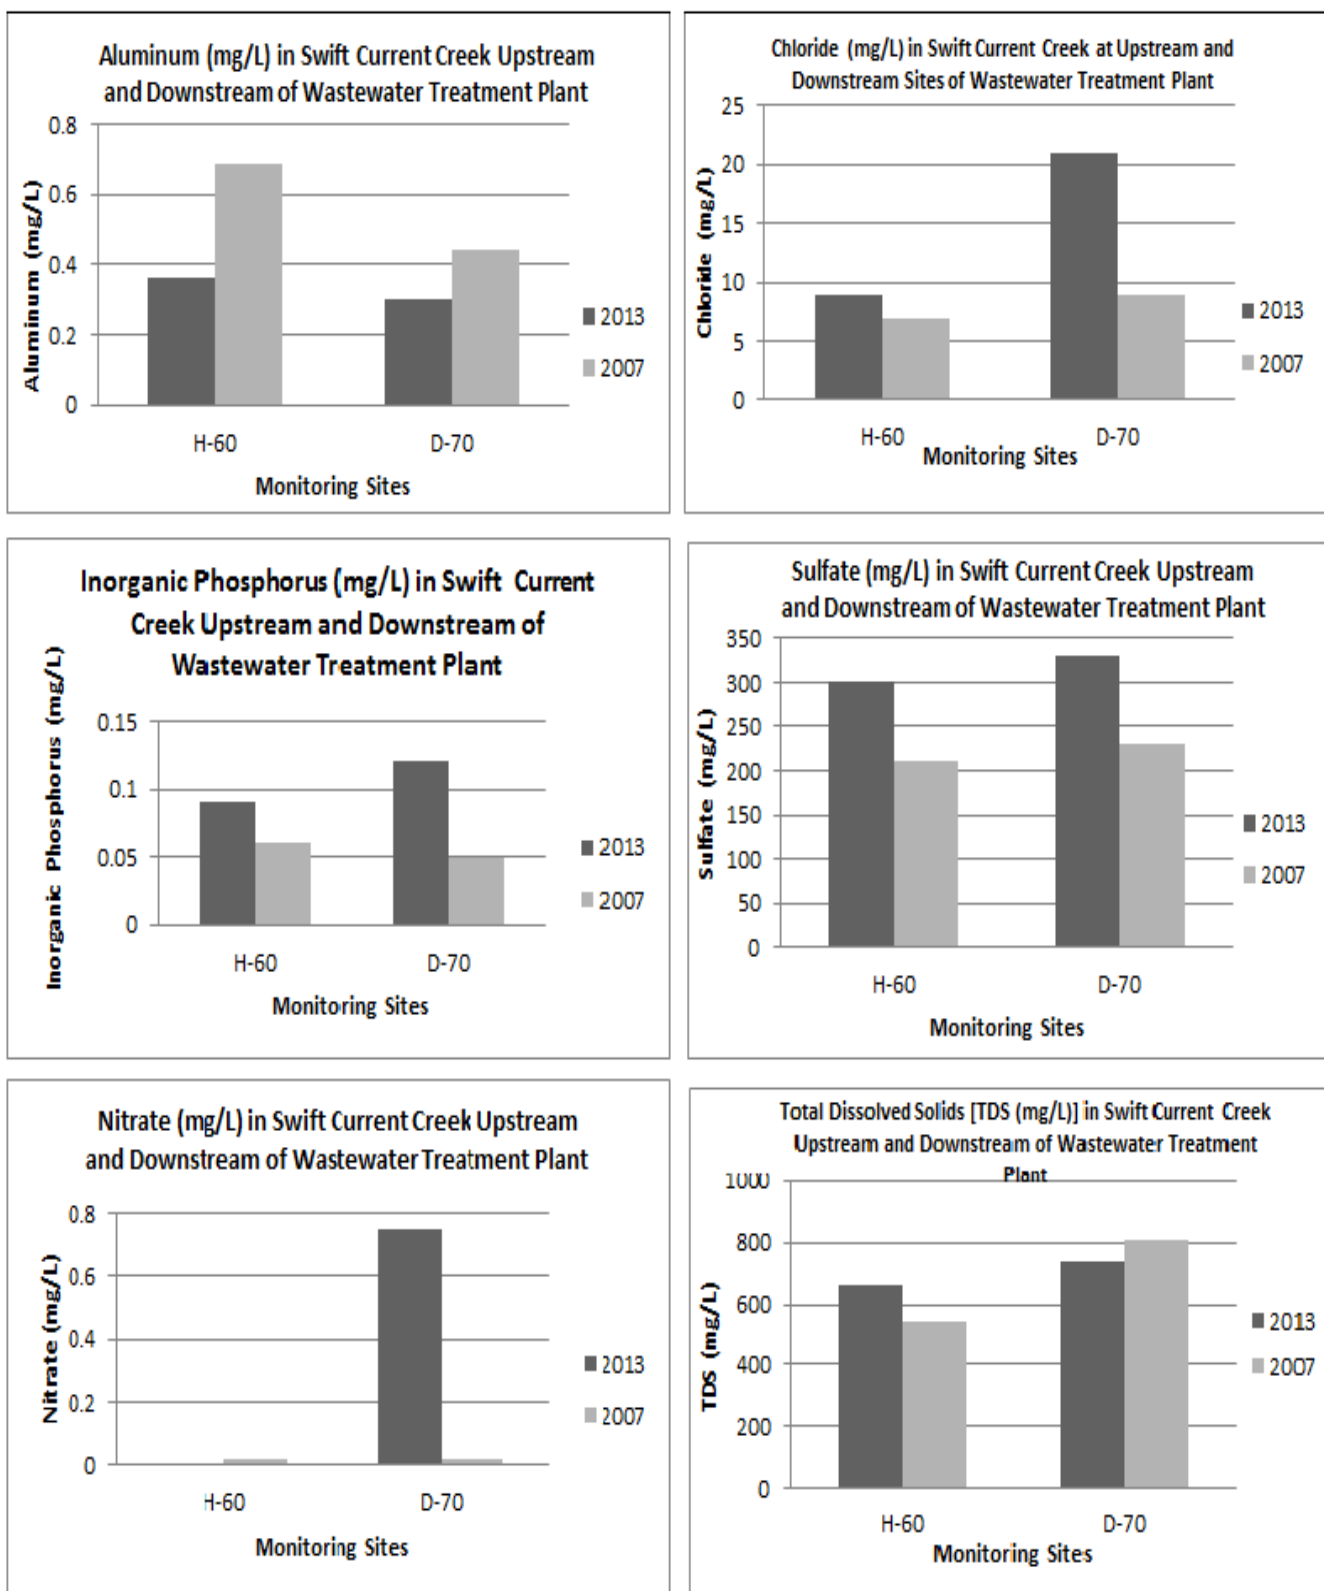
Found in nature only in the form of compounds and not an element, Aluminum can be present in effluents and wash water from wastewater treatment plants (KDW 2007 as cited by Tait 2008). This is used in the form of Alum to remove microorganisms which can alter pH (Tait 2008). D-70 exhibited peaks in Aluminum from 2005 to 2007 as it is immediately downstream of the wastewater treatment plant. In 2013 the levels decreased and were considerably lower than 2007 levels. A short summary on all water chemistry parameters is found in Table 3. Figure 20 illustrates the changes in levels of each watershed health indicator.

Figure 20- Comparison of watershed health indicators

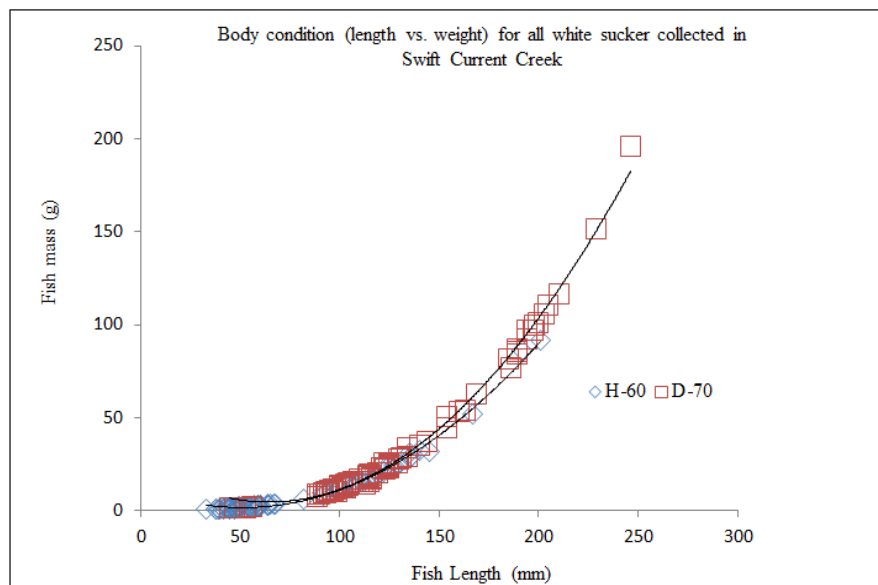
White sucker has always appeared to be an abundant species. Numbers for sentinel data were met at all sites during the 2007 collection. 2013 collection only had D-70 collect the minimum 100 individual requirement and nearly 100 at H-60. Body conditions comparing weight (g) against length (mm) (Figure 25) show similar results between the two sample sites. Data taken in 2007 from site C-50 (which was not included in this survey) shows that there is a gradual increase of relationship in white sucker up to D-70. H-60 with its 2013 debut in bioassessments may show a decrease from C-50 and then continued increase to D-70. This applies to total length, body weight, and condition.

Figure 25- Body condition (length vs. weight) for all white sucker collected in Swift Current Creek (Sereda 2013)

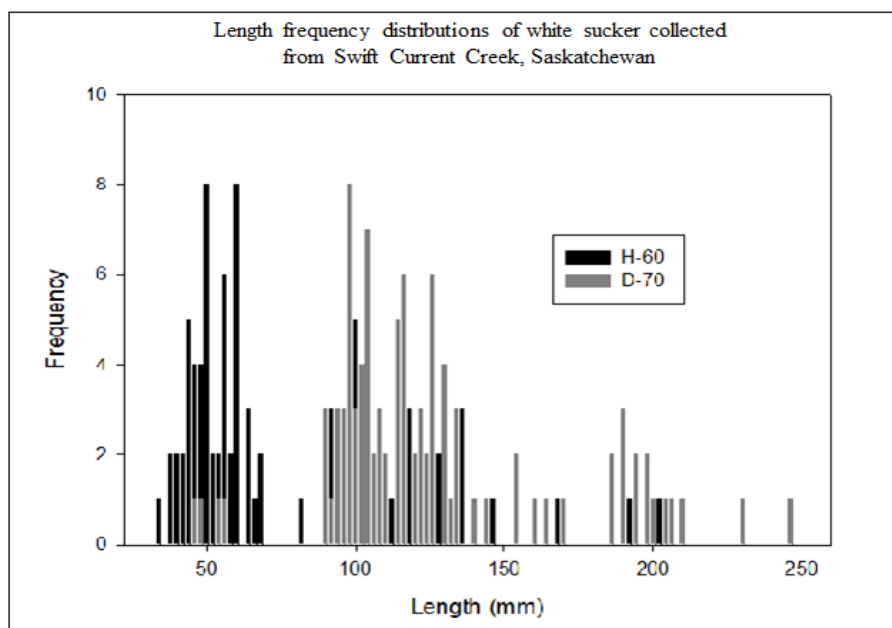
Length frequency distributions were also conducted in white sucker. It was found that H-60 had smaller sizes of fish with two additional cohort sizes within approximately 50 and 125 mm in length respectively. This could also support the proposal that H-60 populations have a drop before rising again at D-70, as the trend indicated in 2007 from C-50 to D-70. Figure 26 shows length distributions of all white suckers, not selectively the YOY as previously analyzed.

Figure 26- Length frequency distributions of white sucker collected from Swift Current Creek (Sereda 2013)

Smaller sizes in the population may suggest that YOY have moved downstream from spawning areas and are gradually working their way back upstream. Weights, lengths, and condition in 2007 all have the highest relationships at the most upstream sites. At C-50 numbers drop off and then increase gradually to D-70. H-60 data may help in future assessments to determine the cause of this community decrease in sizes, weights, and population numbers.

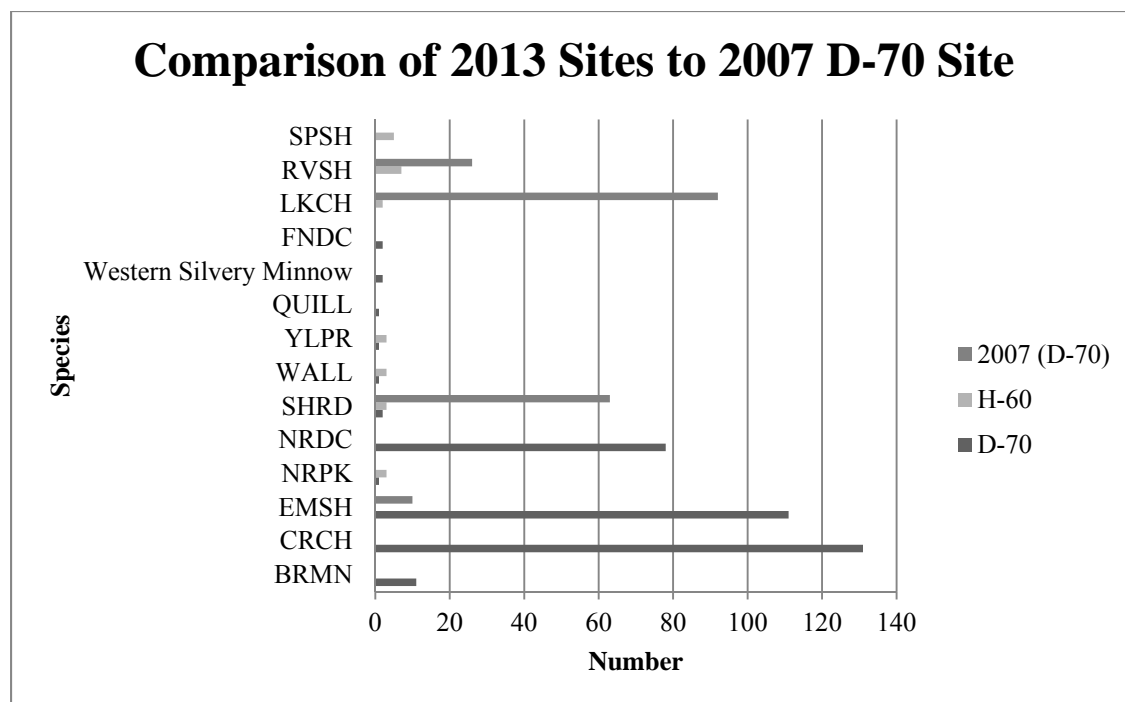
Creek chubs feed on macroinvertebrates and even crayfish as well as smaller fish such as the Johnny darter; an important late-summer food supply (Stewart and Watkinson 2004). Creek chubs were found in great abundance at 131 individuals. Ideally, they also prefer clear water stream habitats with gravel bottoms, and have tolerance for some turbidity (Stewart and Watkinson 2004). These needs are identical to those of the declining species, and perhaps a shift in species composition is happening due to the large creek chub populations with a tolerance for some sedimentation. Species could also breed in other sites but feeding and water quality would be important factors at the D-70 sample site. The following Figure 30 and Table 5 summarizes community species numbers caught in 2007 and 2013.

Figure 30- Comparison of 2013 sites to 2007 D-70 site

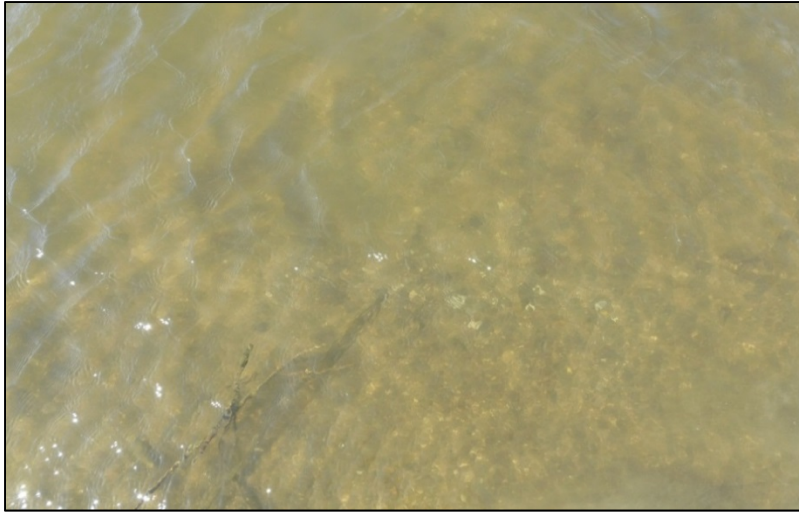
Figure 31- Bottom substrate at transect 2 of D-70

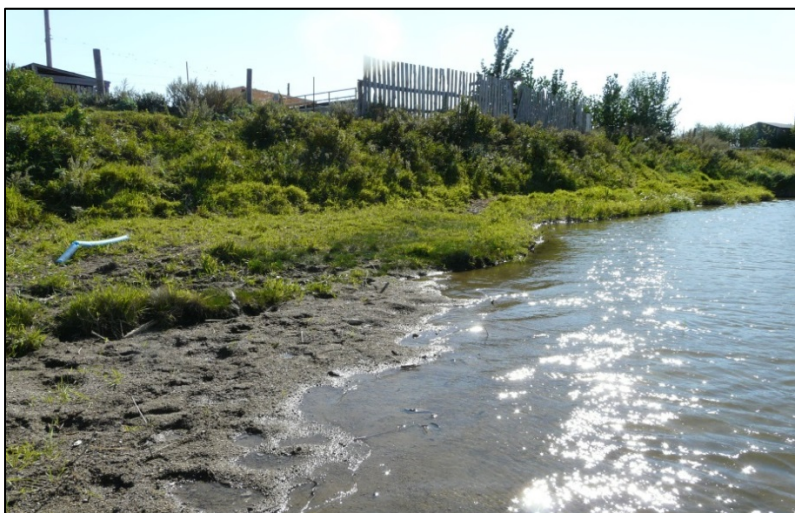
Figure 32- Site assessment at transect 2 of D-70 with extensive use by horses

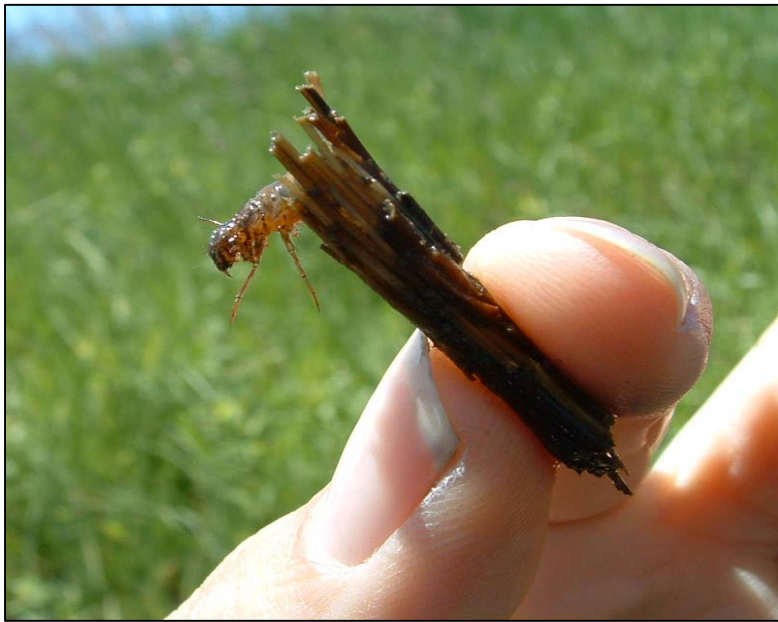
Figure 33- Trichoptera larvae in cocoon made of organic debris (SCCWS 2004)

Trichoptera larvae encase themselves in cocoons constructed of organic debris, small pieces of gravel and even shells held together by silk they produce underwater. They are susceptible to low oxygen levels and different families have been used to classify water types, such as Hydropsychidae (common netspinners), which were found at D-70 (Higler and Tolkamp 1983 as cited by Reynoldson and Metcalfe-Smith 1992). Trichoptera are key indicators due to deviations in populations indicating pollution (Higler and Tolkamp 1983 as cited by Reynoldson and Metcalfe-Smith 1992). Figure 33 shows an example of Trichoptera species.

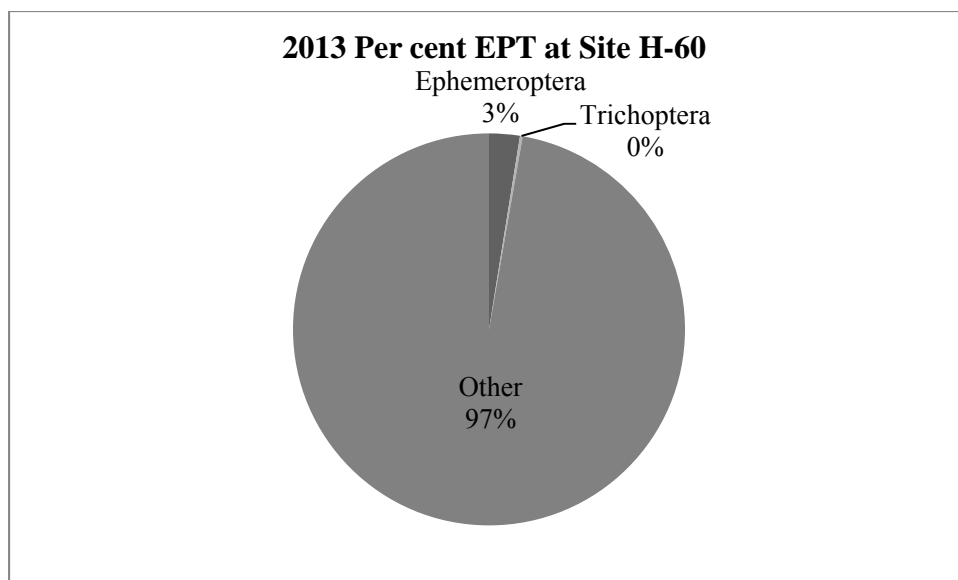
Per cent EPT was calculated for the 2013 data to help further evaluate the health of the sites in question. EPT species are pollution intolerant species (as mentioned previously) and were calculated on a per cent scale. High values indicate good diversity and ecosystems, whereas low percentages do not. If one of the three EPT species is absent or has very low occurring numbers it can also indicate unhealthy systems (Tait 2008). H-60 has extremely low values of only two of the EPT, Ephemeroptera and Trichoptera at 2.53 per cent and 0.23 per cent respectively. D-70 had a higher percentage of Trichoptera at 27.52 per cent; 2007 had 0 per cent Trichoptera, which states improvement, and Ephemeroptera percentage at 1.54 which is based on lower counts in 2013 from 2007. Neither site has sustained Plecoptera. EPT in percentages are shown in Figures 34 and 35 for H-60 and D-70.

Figure 34- 2013 per cent EPT at site H-60

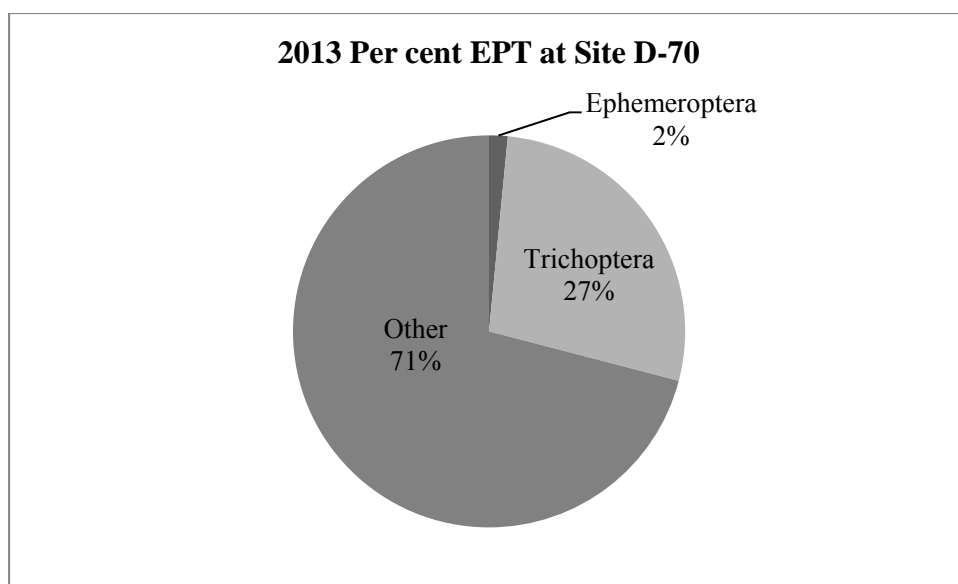
Figure 35- 2013 per cent EPT at site D-70

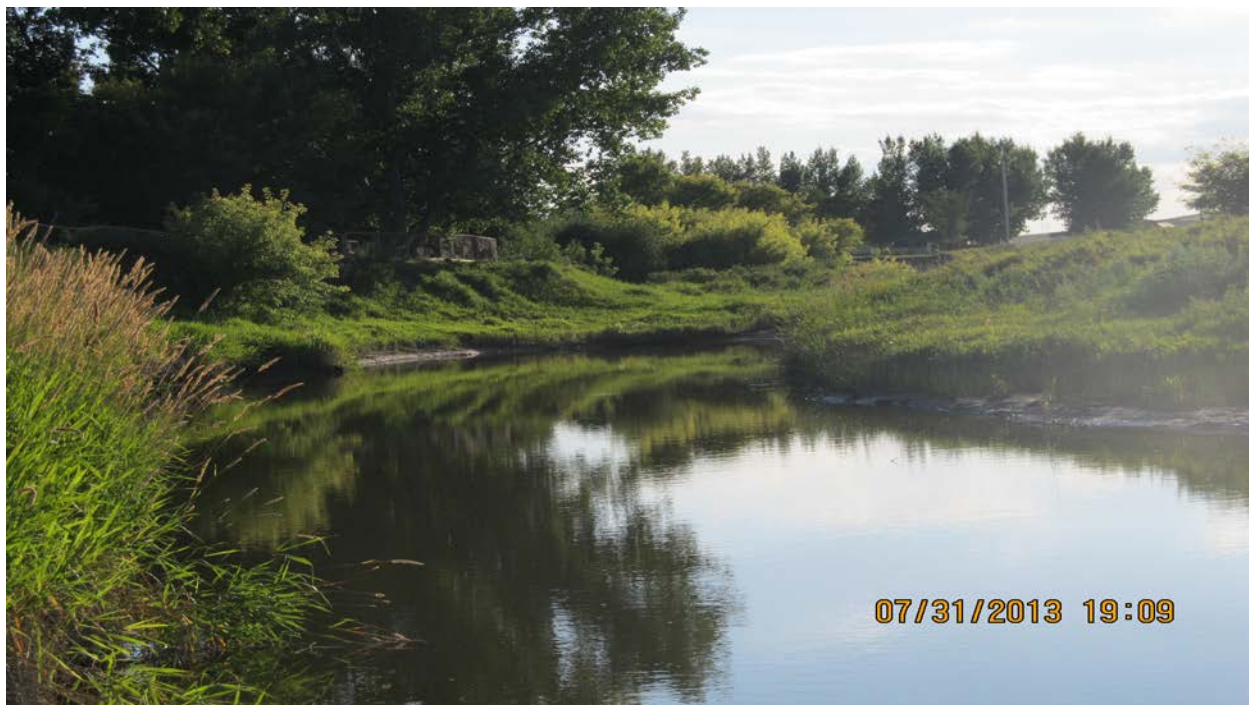
Photo 1 – Facing upstream. Photo showing good vegetative cover. Slight incisement with water being able to access the floodplain on inside meander.

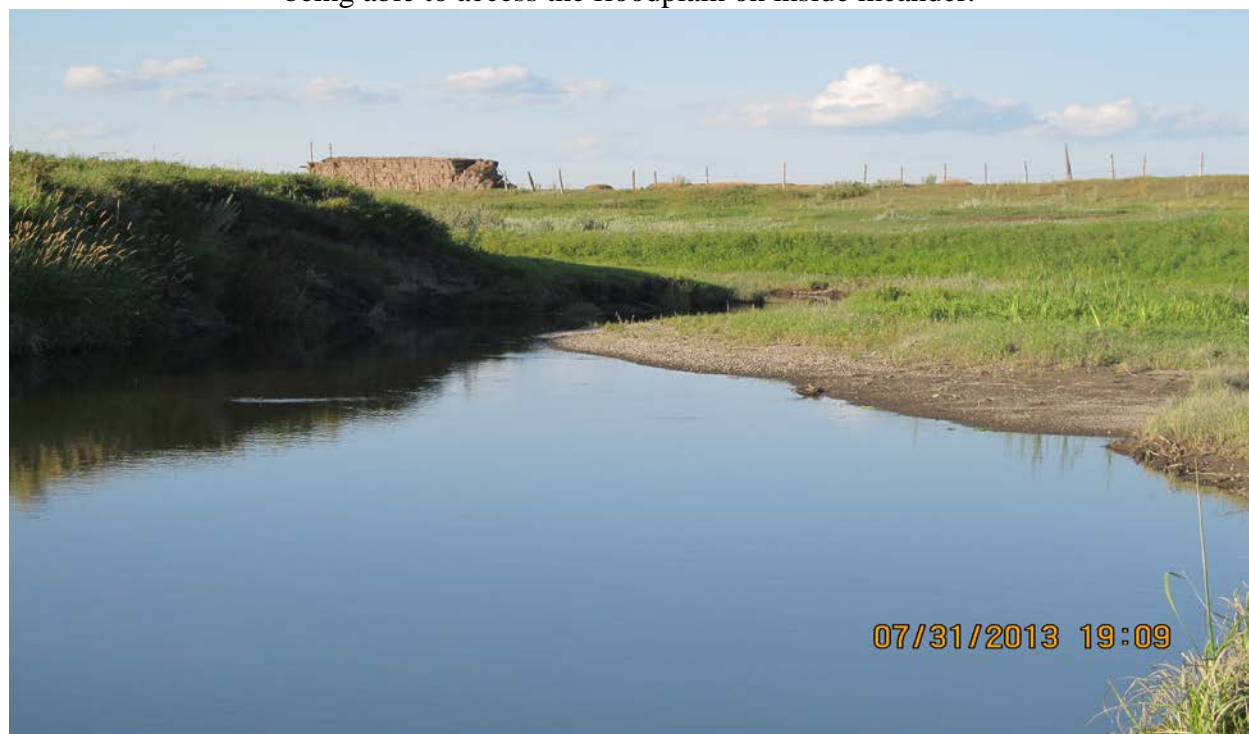
Photo 2 – Facing upstream. Photo showing where water can easily reach floodplain on inside meander. Active lateral cutting and slumping on outside meander.

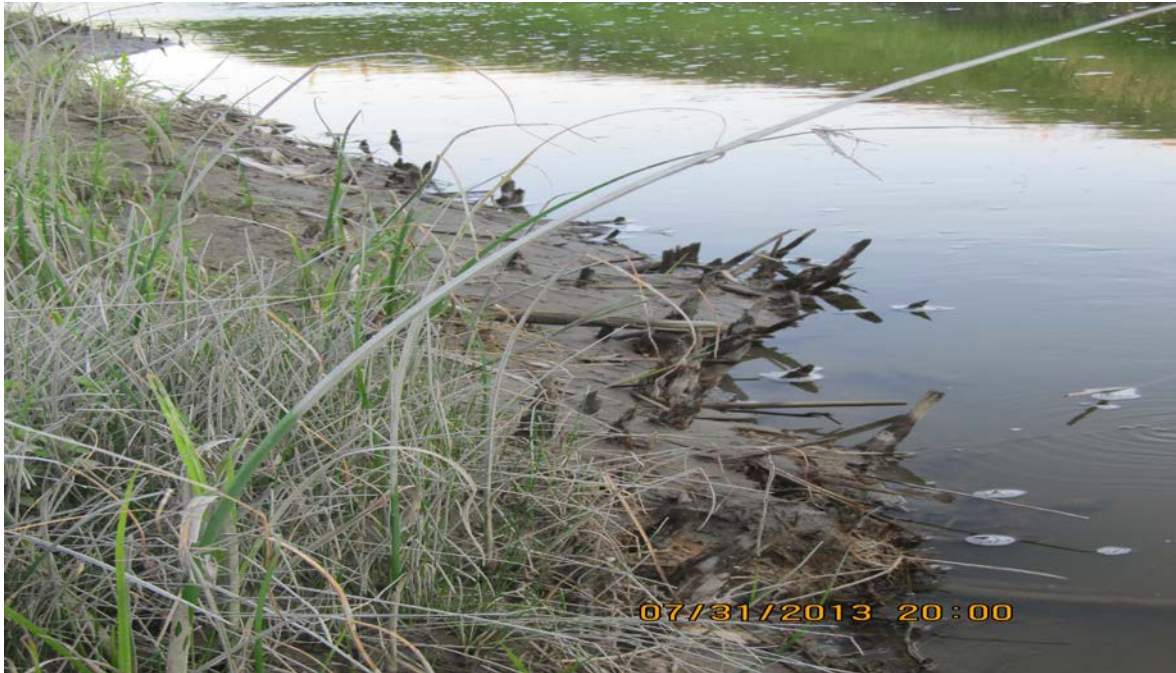
Photo 3 – Showing vegetative cover along streambank. Cattails and sedges present along the water's edge provide excellent stabilizing properties.

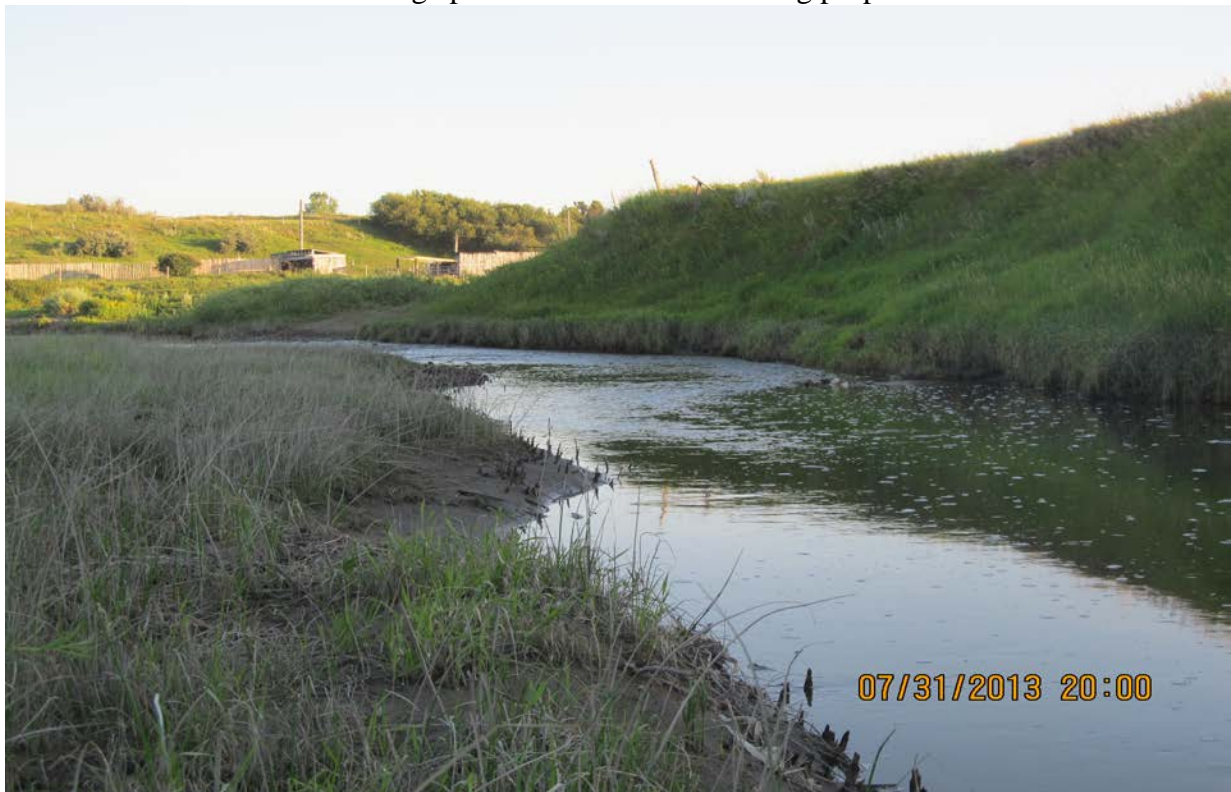
Photo 4 – Facing upstream. Photo showing good vegetative cover. Water levels can easily reach floodplain on east bank.

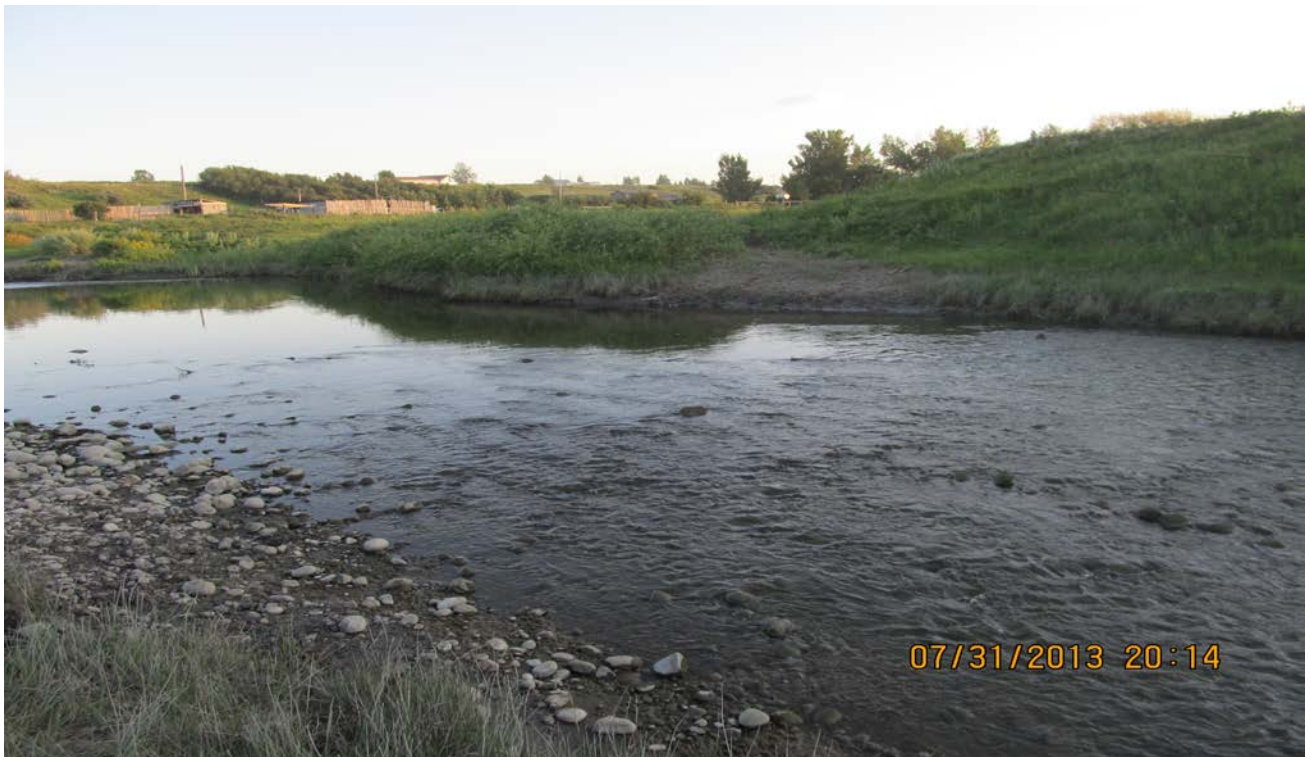
Photo 6 – Facing upstream. Showing area where horses cross.

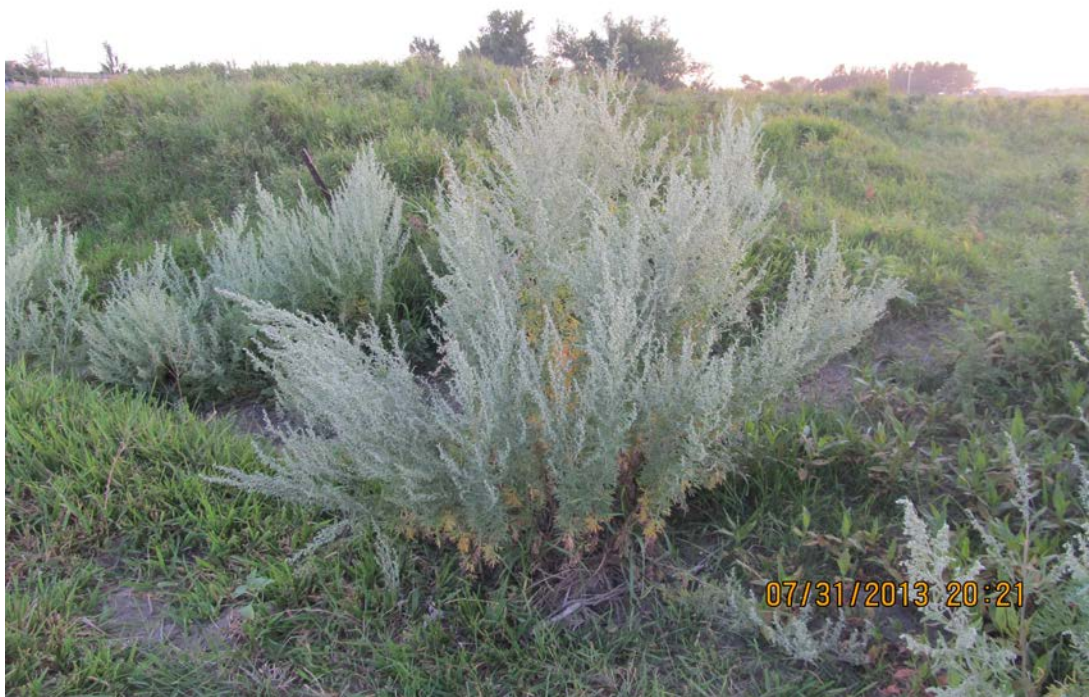
Photo 8 – Absinth (*Artemisia absinthium*). Invasive weed present along streambank.

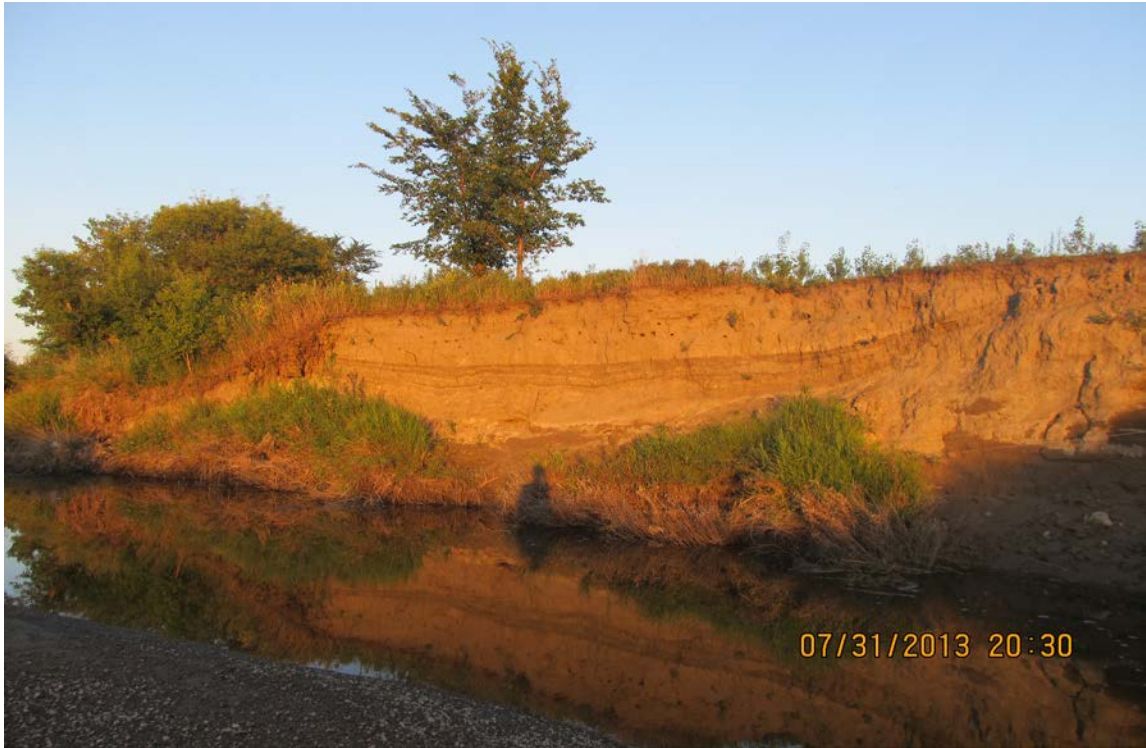
Photo 9 – Photo showing active lateral cutting on outside meander.

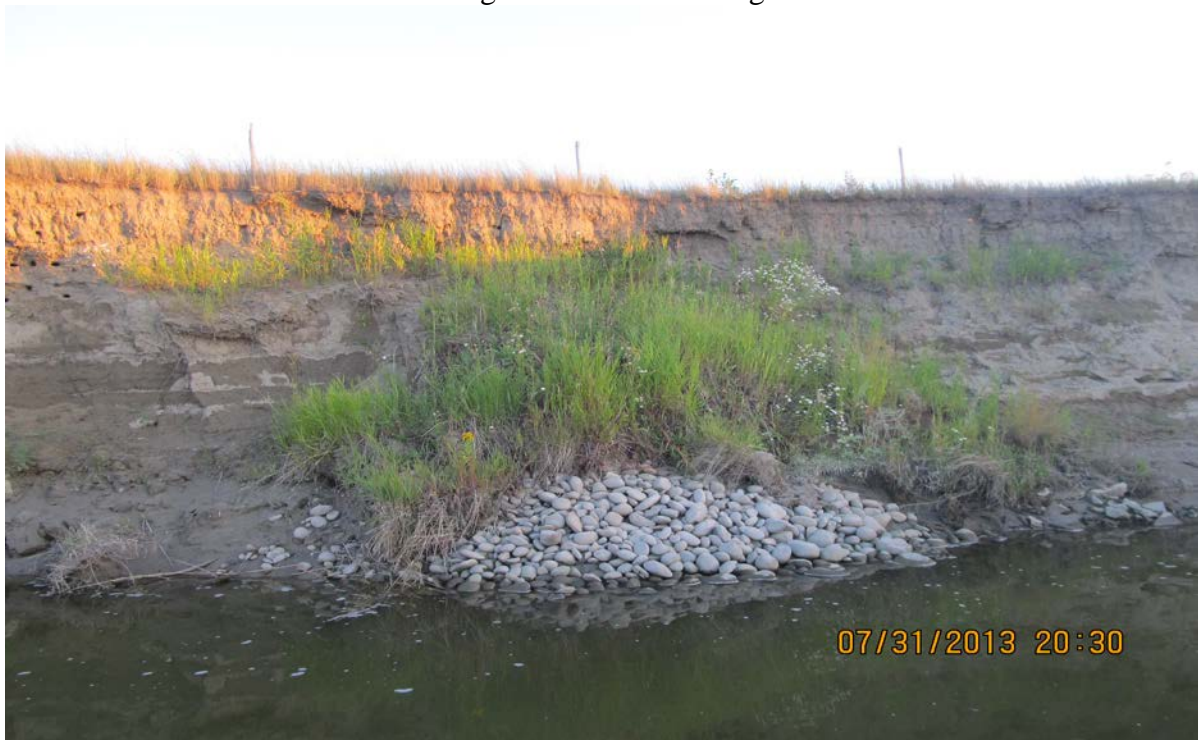
Photo 10 – Photo showing active lateral cutting and rip rap that was brought in.

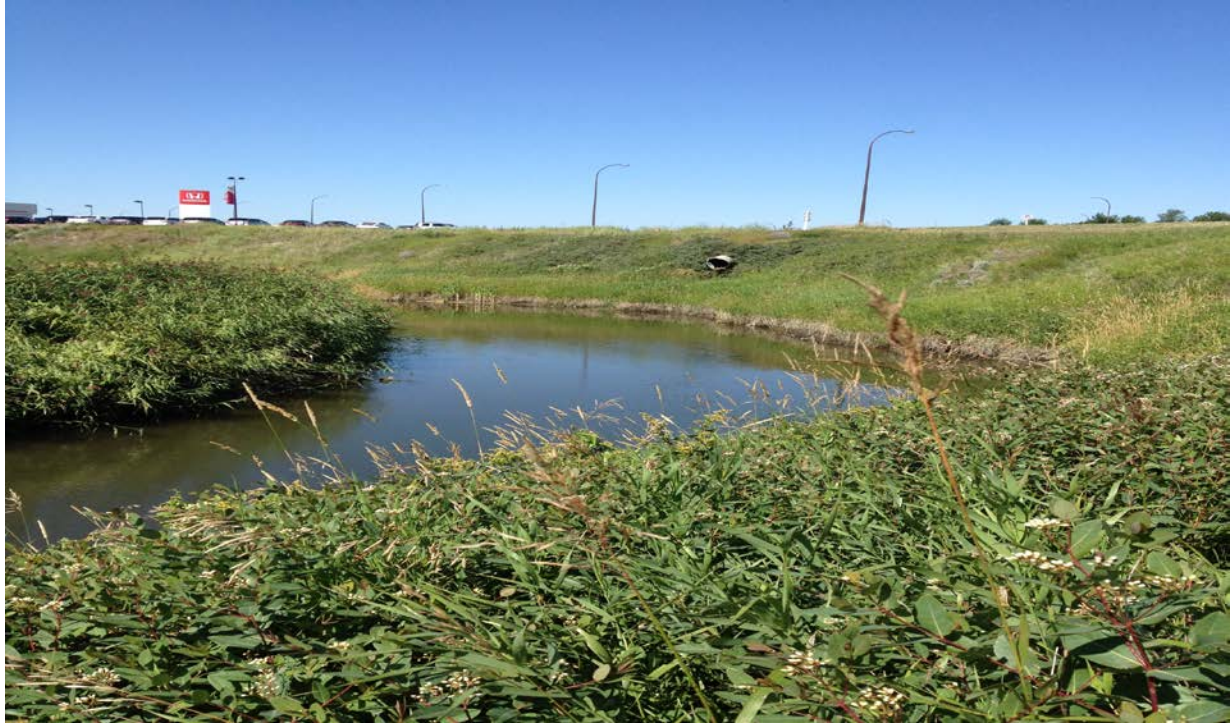
Photo 1 – Facing upstream. Photo showing good vegetative cover. Storm drain construction has altered stream bank.

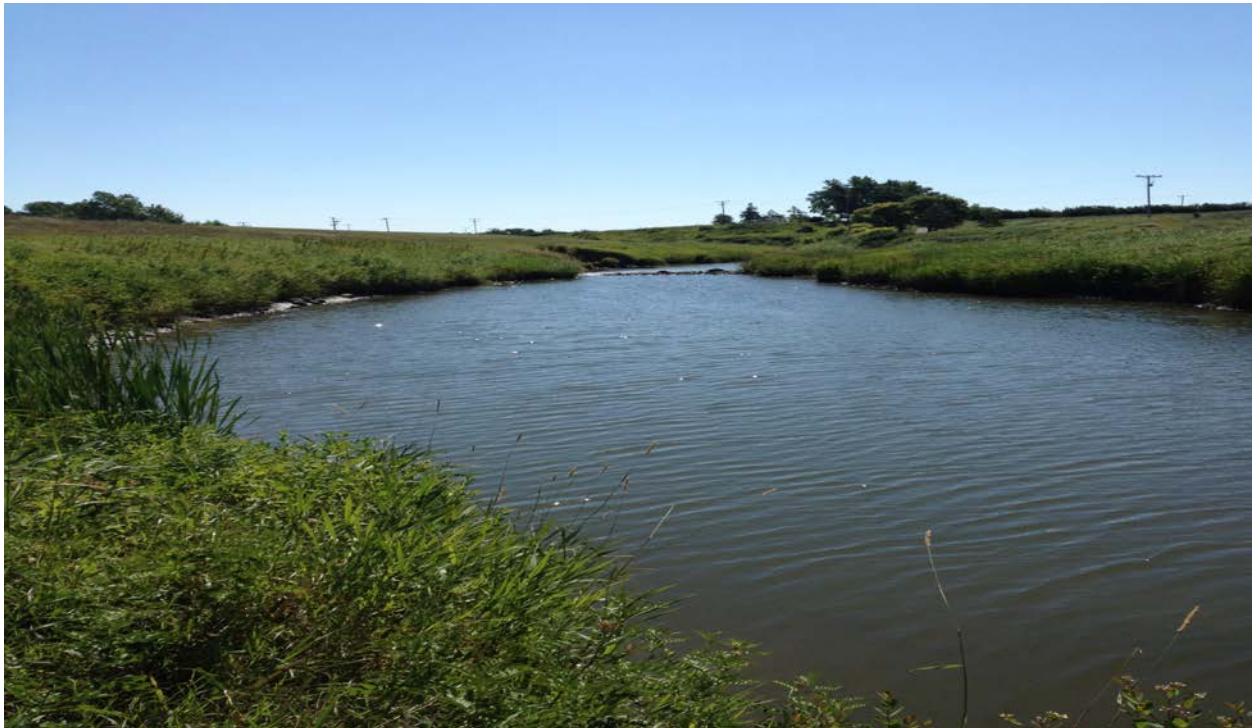
Photo 2 – Facing downstream. Photo showing good vegetative cover. Woody species present. Golf Course activity on south bank and no active use on north bank.

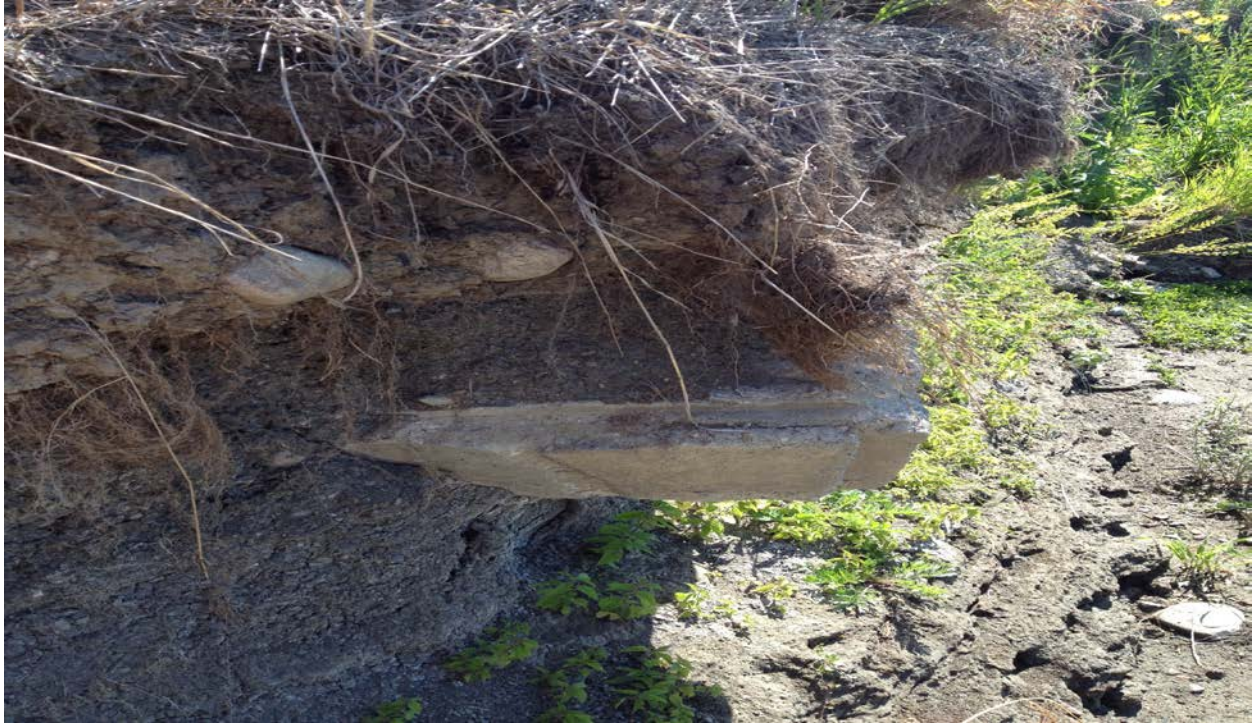
Photo 3 – Showing rip rap that was placed along north bank of Swift Current Creek.
