# Swift Current Creek Watershed Stewards Monitoring Project 2013

A Comparative Biomonitoring Assessment on the Macroinvertebrate Communities  
and Populations in Relation to the Operation of the Swift Current Waste Water  
Treatment Plant

Prepared for: The Swift Current Creek Watershed Stewards

November 29<sup>th</sup>, 2013

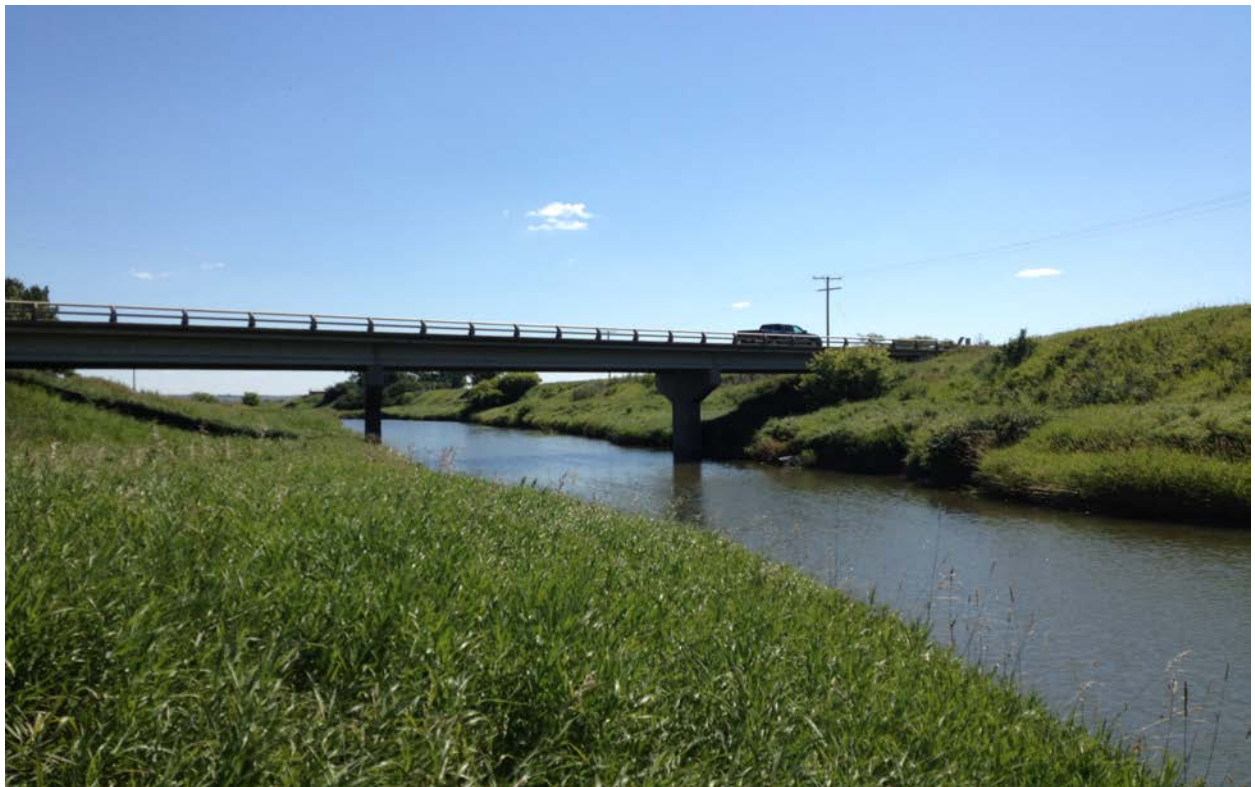
Photo 4 – Facing downstream towards #4 highway bridge. The assessment area ends at the bridge.

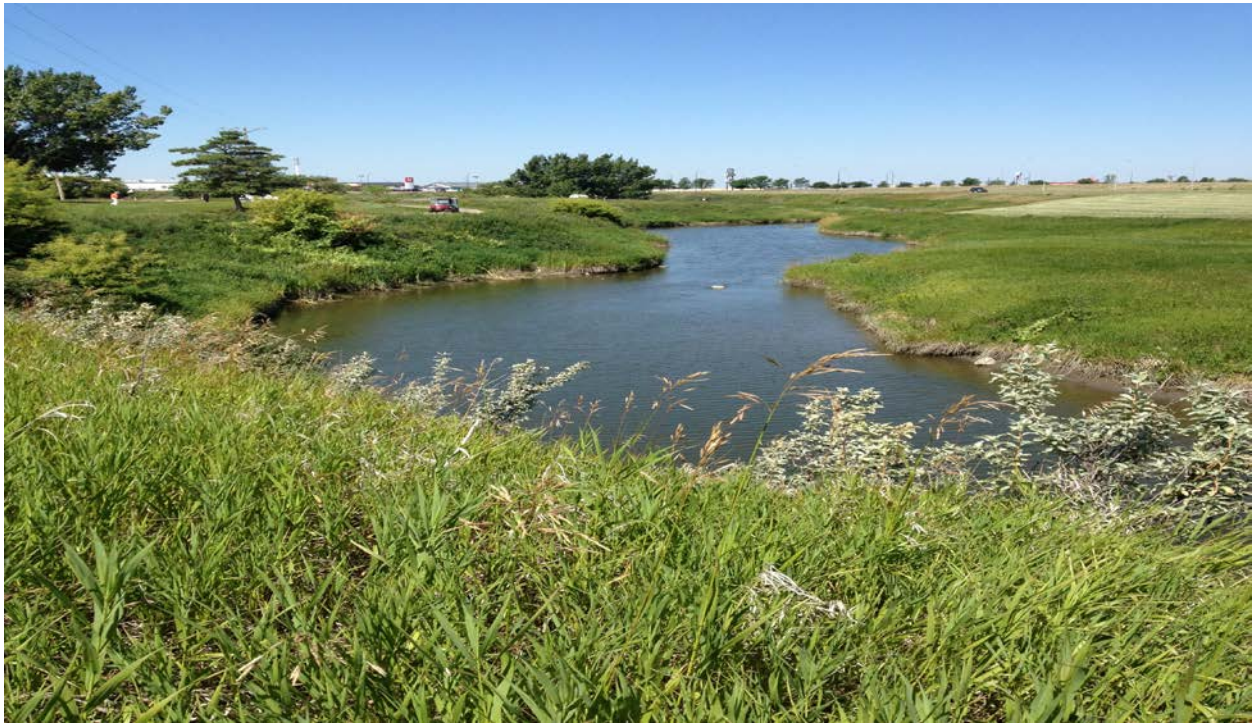
Photo 5 – Facing upstream. Good vegetative cover, minimal bareground, moderate incisement. Water level can reach floodplain on north bank.

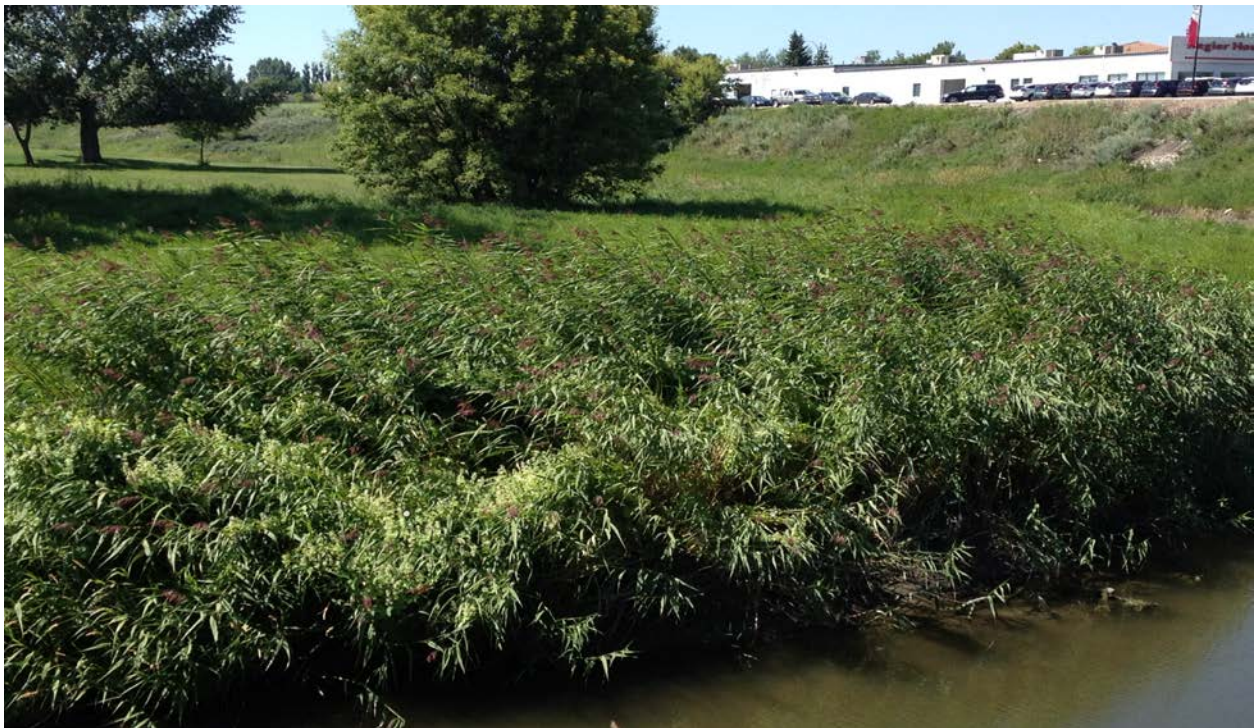
Photo 6 – Photo showing adequate vegetative cover.

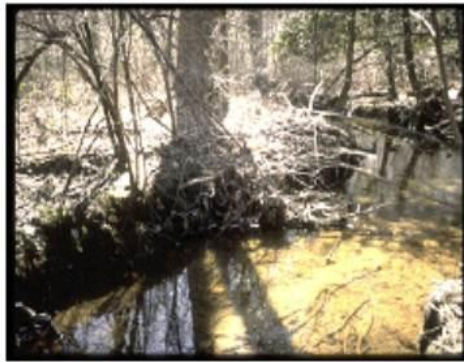
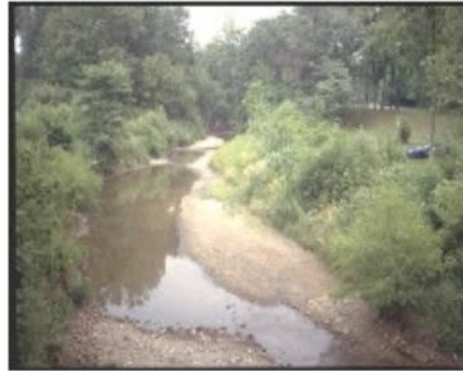
- iii. **Channel flow status:** the degree to which the channel is filled with water. The water level will increase as the channel enlarges in an actively widening channel, or decrease as a result of obstructions upstream or drought. Less water in the channel limits the available habitat for macroinvertebrates to colonize. This observation can be important when interpreting biological assemblages under abnormal or lowered flow conditions and when sampling times are inconsistent between seasons. **Scoring:** note the channel flow status from 1-20, with 20 being the most optimal condition, on the field data sheet (Figure 4). Also note channel alterations. That is any large-scale changes in the shape of the stream channel due to urban or agriculture alterations.

Figure 4: Range for channel flow status, and associated scoring from optimal condition with high channel flow and high score (20) to poor conditions with little channel flow and low score (0). The scoring and figure is reproduced from Barbour et al. 1999.

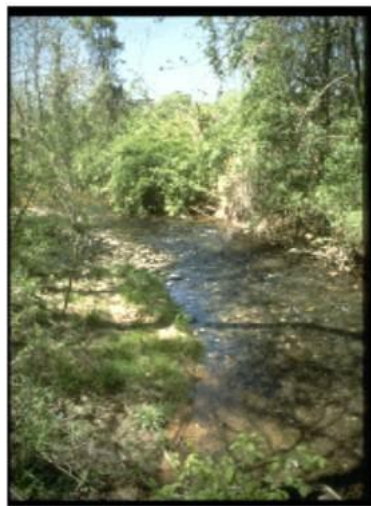
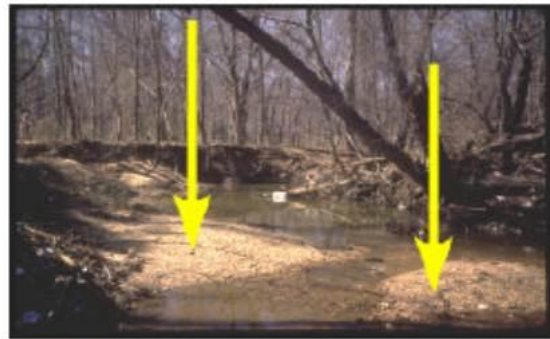
- iv. **Sediment deposition:** Not to be confused with embeddedness, sediment deposition describes the accumulation of sediment in pools and how this sediment alters the bottom of the stream. **Scoring:** observe the formation of islands indicating heavy deposition of fine sediment. Figure 5 shows examples of each and the definitions for optimal to poor conditions. For complete guide of soil phase, including water and water erosion, refer to Hayes (1998).

Poor Range  
(arrows pointing to sediment deposition)

Figure 5: Range for sediment deposition condition, and associated scoring from optimal condition with little or no increased sediment deposition with high score (20) to heavy deposits of sediment with a low score (0). Scoring and figure reproduced from Barbour et al. 1999.

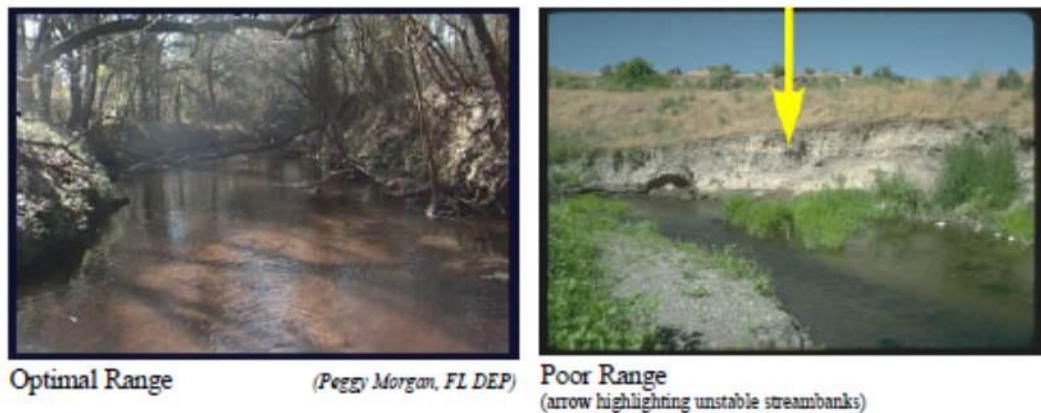
- v. **Bank Stability Score:** A measure of the condition of the banks, whether they are eroded or have the potential for erosion. Signs of erosion include exposed tree roots, non-vegetated banks. Steep banks have a higher potential to erode than shallow sloping or even overhanging banks. **Scoring:** The right and left banks (facing downstream) are scored independently and given a score from 1-10, from the EPA Rapid Bioassessment protocols for Use in Streams and Wadeable Rivers. Scoring details and examples illustrating optimal and poor range are shown in figure 6 below.

Figure 6: Range of bank stability condition, and associated scoring from optimal conditions with highly stable banks and a high score on the left and right banks (10, 10) to a poor bank stability with a low score on the left and right banks (0.0). Scoring and figure reproduced from Barbour et al. 1999.

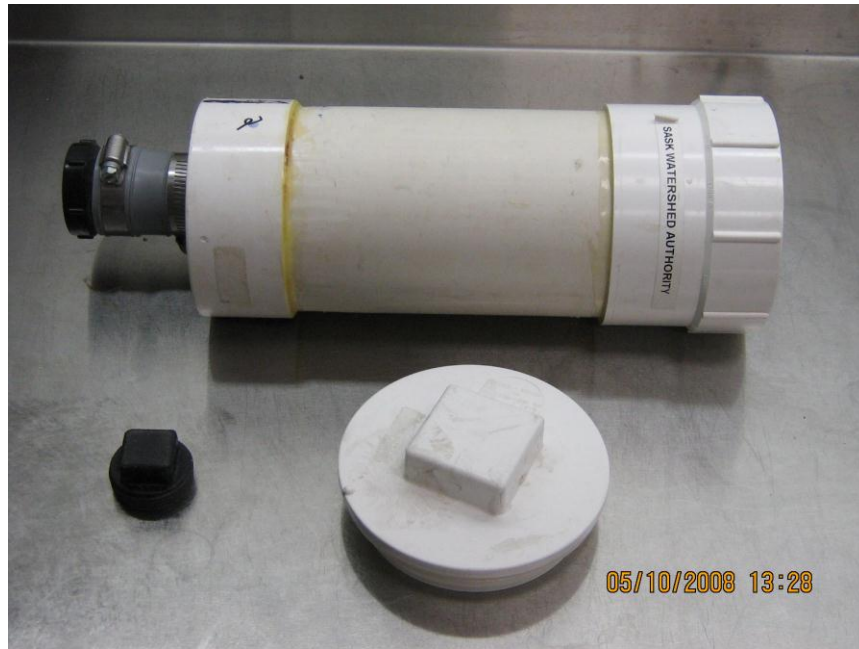
**Figure 9. BENT Lab benthos sample splitter from side view with lid in the fore middle of the picture, and the spigot cap to the fore left in the picture (photo by I. Phillips).**

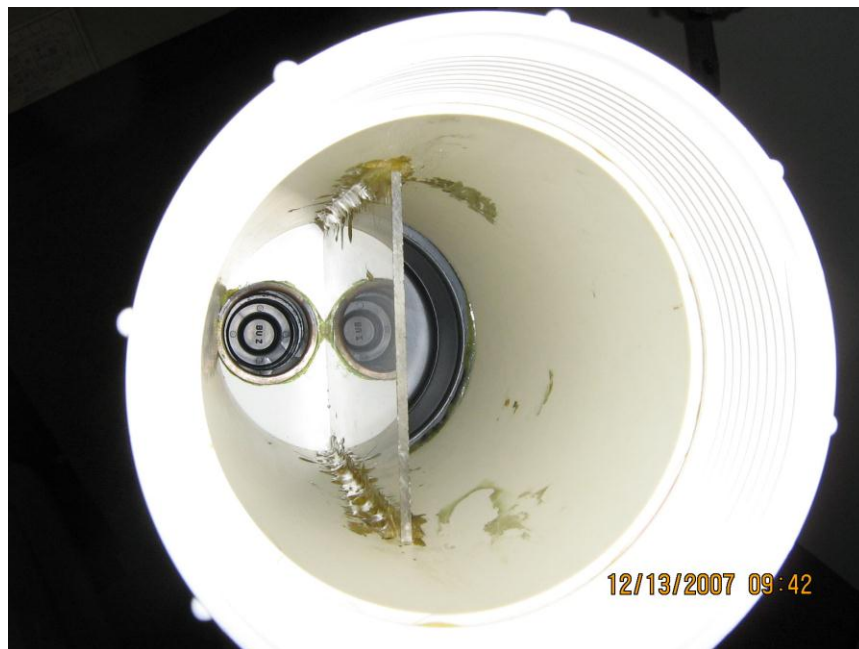
**Figure 10. BENT Lab sample splitter from top view. Note the spigot outlet on the left, the dividing plexiglass in the middle, and the closed half chamber on the right (photo by I. Phillips).**

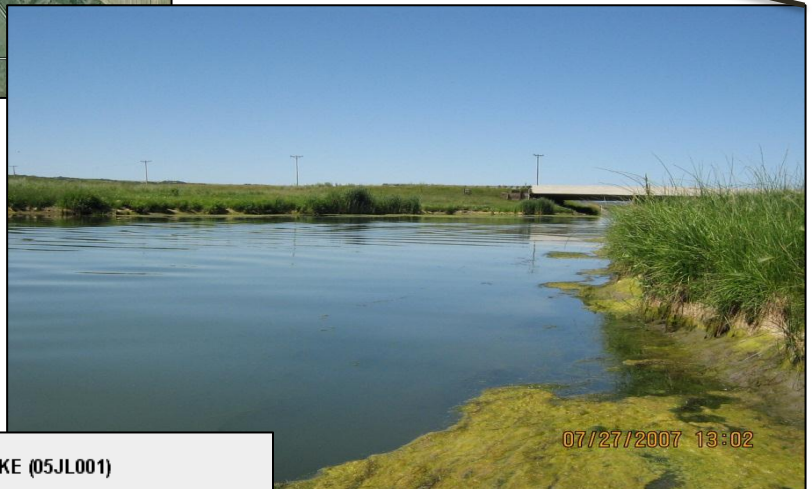
## Site Image:

- To access the site follow Highway 56 from Fort Qu'Appelle along Katapwa lakes and sample ~100 downstream of the bridge on Highway 56 to avoid influences of the water control structure.
- The site has shallow banks and is easily accessible from the bridge.

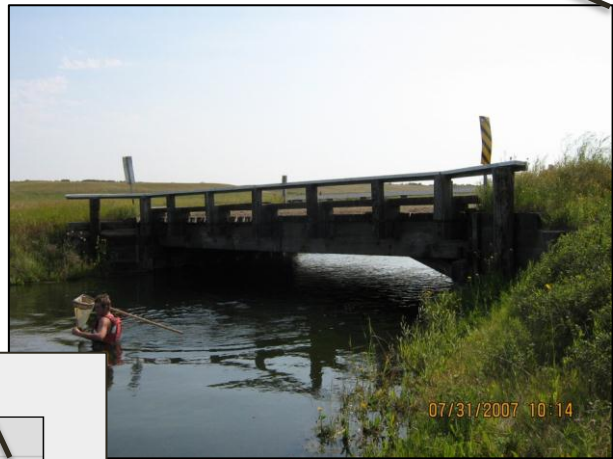
### Site Image:

- The site is located ~100 m upstream from the bridge of Highway 19 over the Qu'Appelle River, north of Bridgeford, SK.
- It is characterized as a highly vegetated area with many submerged macrophytes and a muddy bottom. It is easily accessed upstream of the bridge.
- -The reach has low flow with median annual volume 70500 dam<sup>3</sup>, median peak flow 6.6 m<sup>3</sup>/s, and minimum peak flow 0.05 m<sup>3</sup>/s.

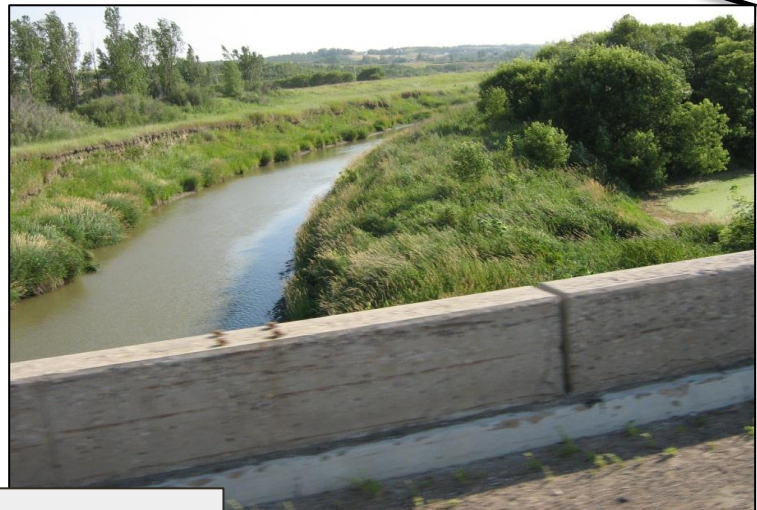
#### Site Image:

- This site is located under the overpass of Highway 11
- This site has highly vegetated and steep banks with a mostly muddy bottom. The reach is accessible by walking along the bank under the bridge.
- At this site the median annual discharge is 122932.4256  $\text{dam}^3$ , median peak flow is  $26.5 \text{ m}^3/\text{s}$  and the median minimum flow is  $0.264 \text{ m}^3/\text{s}$ .

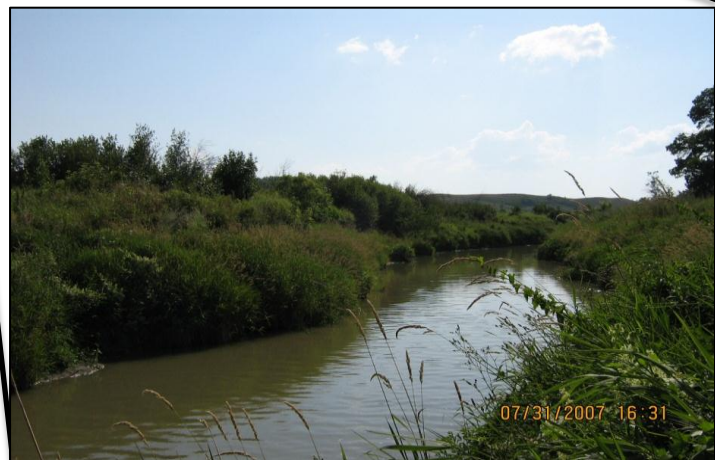
### Site Image:

- Heading west of Lumsden on Qu'Appelle Drive (Grid 641), turn right on the continuation of Grid 54. The site is immediately upstream the bridge on Grid 54.
- The site is has vegetated and shallow banks. It is easily accessible by walking along the bank 100m upstream from the bridge.
- From available hydrometric data for this site the median annual discharge is  $91390.9 \text{ dam}^3$ , the median peak flow is  $18.55 \text{ m}^3/\text{s}$  and the median minimum flow is

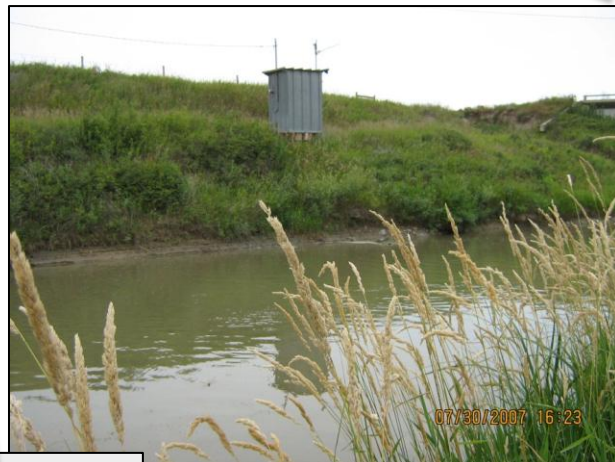
### Site Image:

- Site is located immediately upstream, or west, of the crossing of Grid 640 and the Qu'Appelle River north of Edenwold.
- Highly vegetated, steep banks. Access by climbing down along the bridge abutment, and walking upstream along the slump above the bank.
- At this site, mean annual discharge is 124516.8288, dam<sup>3</sup>, median peak flow is 18.1 m<sup>3</sup>/s and 5-year median minimum flow is 0.418 m<sup>3</sup>/s.

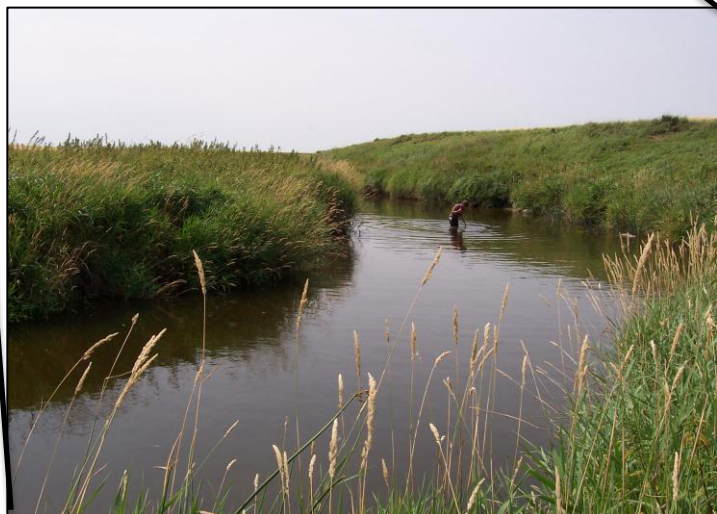
### Site Image:

- The site is located downstream of Regina's wastewater treatment plant. From Regina, exit Dewdney Avenue to Grid 730. Turn north on the grid just east of the Sherwood Forest grid to Sidmar Crossing.
- It is a shallow, narrow location with highly vegetated, steep banks.
- Hydrometric data shows the median annual discharge is  $2941.7472 \text{ dam}^3$ , median peak flow is  $2.41 \text{ m}^3/\text{s}$  and median minimum flow is  $0 \text{ m}^3/\text{s}$ .
- **Collect isotonic data at this site**

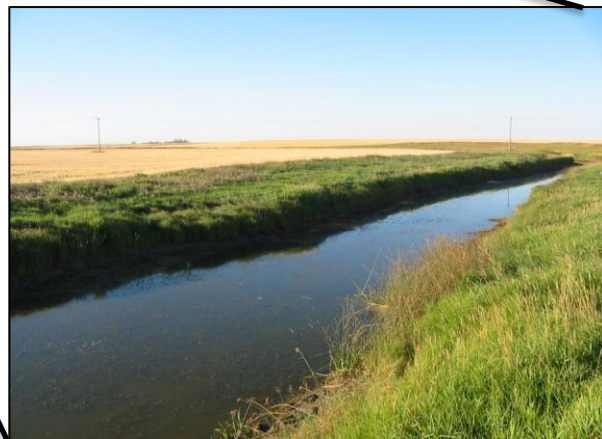
**Site Image:**

- Site located off Highway 33 and is located directly west of Kronau, SK.
- This narrow stretch of Wascana Creek is located in an agriculturally- dominated area with a small riparian area.
- Median annual flow is  $13970.448 \text{ dam}^3$ , median peak flow is  $11.9 \text{ m}^3/\text{s}$  and median minimum flow is  $0 \text{ m}^3/\text{s}$ .
- **Collect isotopic data at this site following Section 4.**

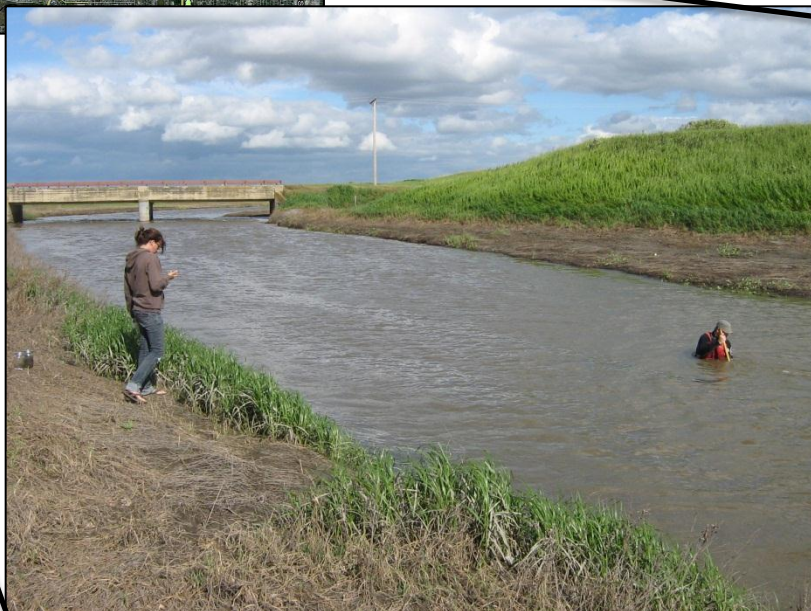
### Site Image:

- Upstream of the Regina Sewage Water Treatment Plant. From Regina, exit Dewdney Avenue to Grid 730. Turn north on the grid just east of the Sherwood Forest grid to Riske's Crossing.
- This site has muddy banks and a primarily mud substrate.
- Median annual discharge is 2941.7472, median peak flow is 2.41 and median minimum flow is 0.
- **Collect isotopic data at this site following Section 4.**

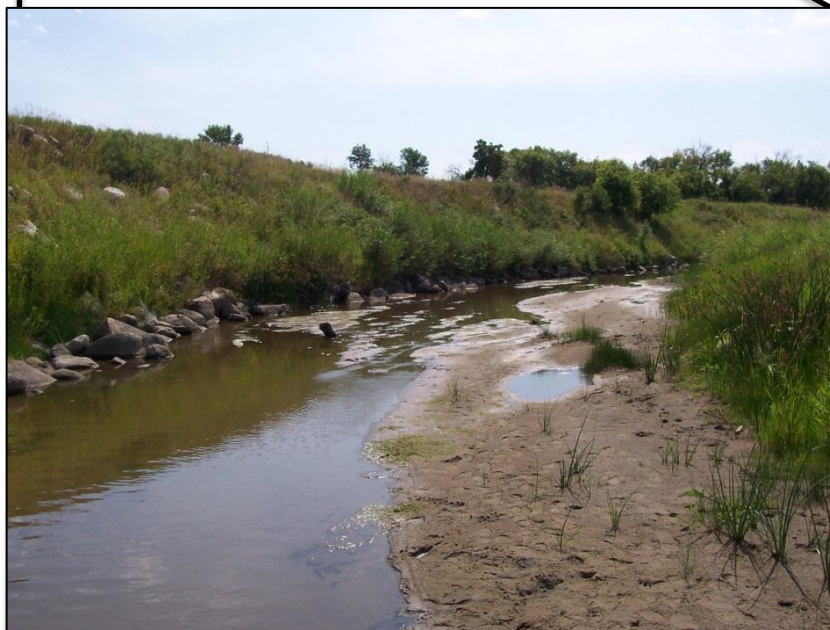
## Site Image:

- South of Buffalo Pound Provincial Park and is best accessed following Grid 642 following the map shown below.
- This site is typically very shallow with steep banks and has sandy substrate.
- **Collect isotopic data at this site following Section 4.**

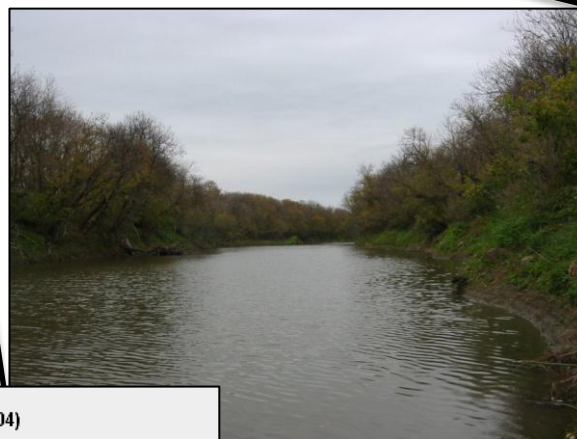
## Site Image:

- Site is located immediate west of Kamsack off Highway 5.
- Bottom substrate is predominantly mud with some cobble. Boreal transition ecozone so coniferous vegetation is present.
- Median annual discharge is  $139104.5184 \text{ dam}^3$ , median peak flow  $55.3 \text{ m}^3$  and median minimum flow  $0.054 \text{ m}^3/\text{s}$ .

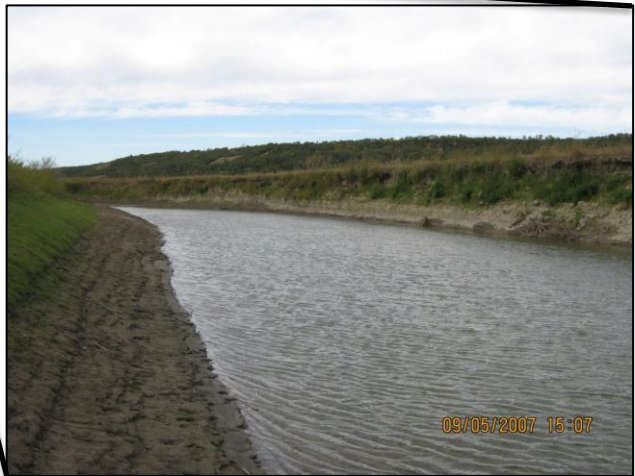
### Site Image:

- Site is located south of Welby and east on a Grid off Highway 8.
- The site is a shallow area with mud substrate.
- Median annual flow is  $173239.6896 \text{ dam}^3$ , median peak flow  $39.75 \text{ m}^3/\text{s}$  and median  $^2$

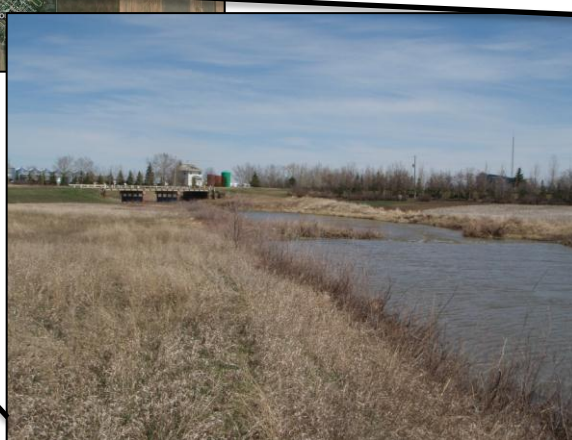
### Site Image:

- Located directly east of Roleau, it is accessible easily by following the grid road shown in the map below.
- Current hydrometric data is unavailable, however median annual discharge from 1944 to 1992 at this site is  $752.3 \text{ dam}^3$ .
- This is an area with low flow and the median peak flow and minimum flow are both near 0
