# Swift Current Creek Watershed Monitoring Project

## Final Report

**SWIFT CURRENT CREEK**  
*Watershed Stewards*

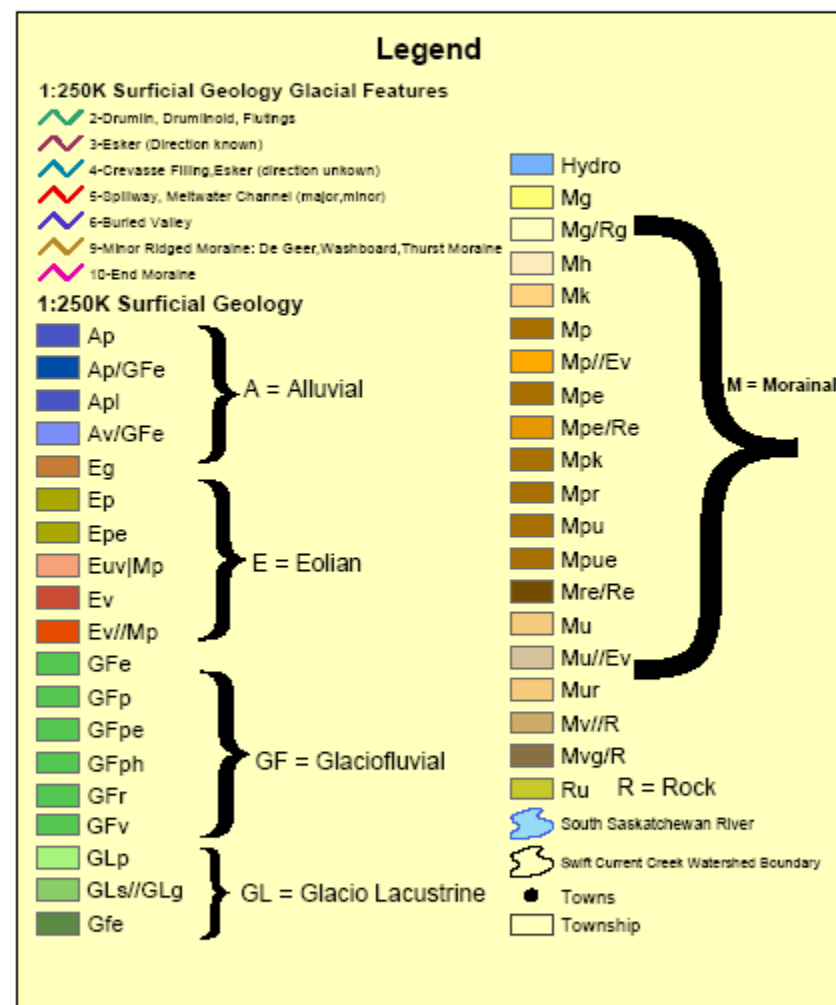
Figure 5: Swift Current Creek Watershed Surficial Geology Map (Yasul, 2004)

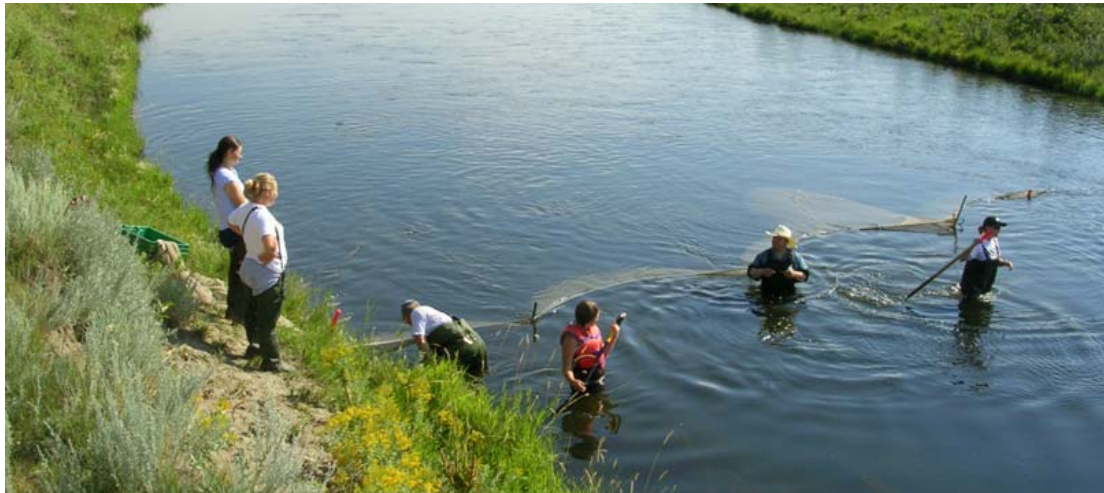
**Figure 8: Block nets being set up**

Upon arriving at each site, the first task was putting up block nets 100 m upstream and downstream of the hub to quarantine the sampling area (Fig. 8). Due to high water flows metal t-posts had to be used to secure the block nets. The block net was cleaned occasionally to alleviate some weight on the nets.

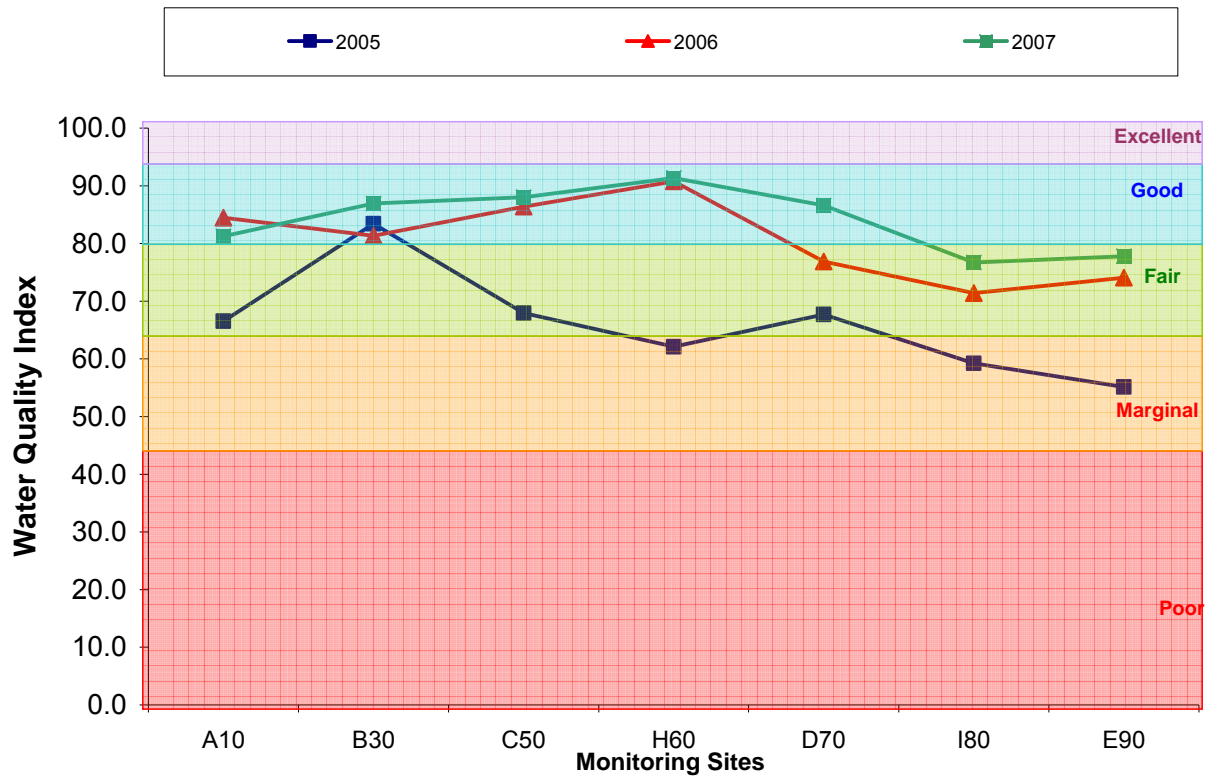
**Figure 13: Water Quality Indices for General Water Use in Swift Current Creek from 2005-2007.**

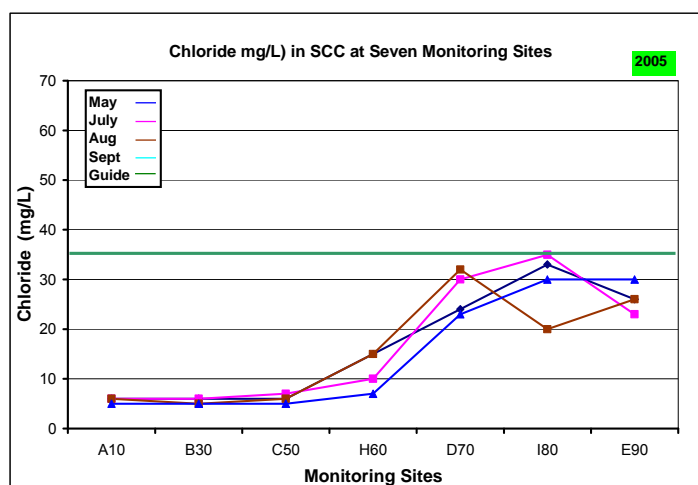
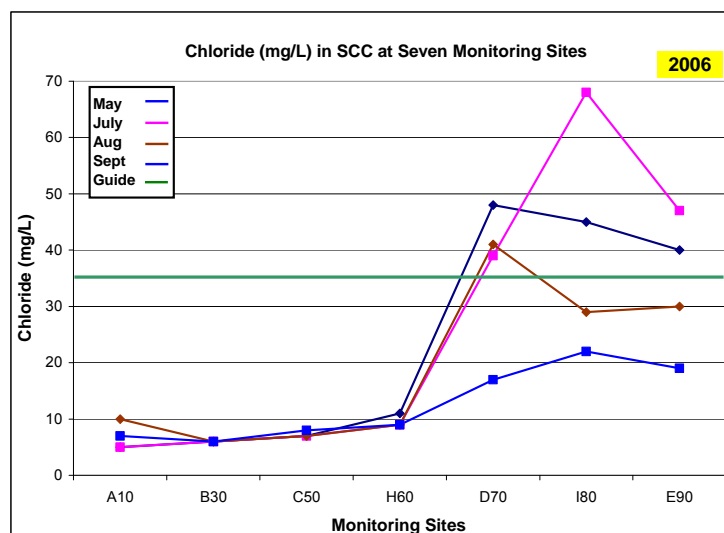
Figure 14: Chloride levels in Swift Current Creek in 2005

Figure 15: Chloride in Swift Current Creek in 2006

Figure 16: Chloride in Swift Current Creek in 2007

The concentrations of chloride in the SCC show a similar pattern among all three sample years. Between sites A10 and C50 the chloride concentrations are relatively uniform and low. At site H60, chloride begins to rise until it generally peaks at D70; thereafter, chloride usually declines to E90. One reason for the peak at D70 may be attributed to the WWTP. Chloride is present in wastewater and site D70 is immediately downstream from the WWTP; thus, the possibility exists that the effluent released from the WWTP contains enough chloride to raise the levels at site D70.

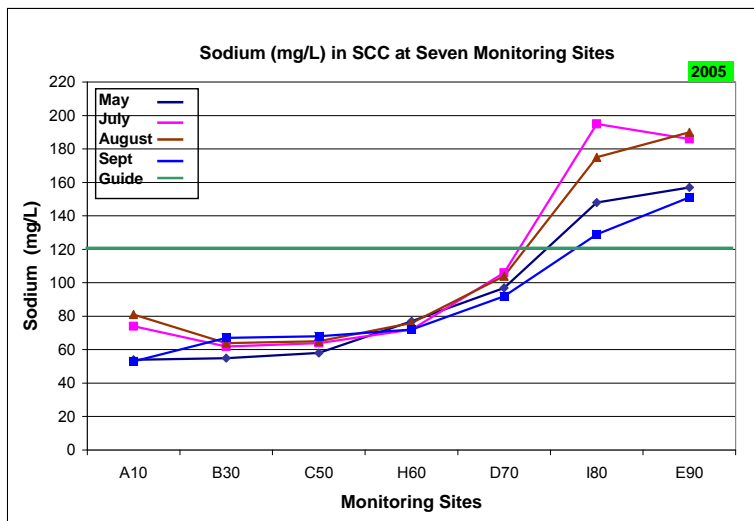
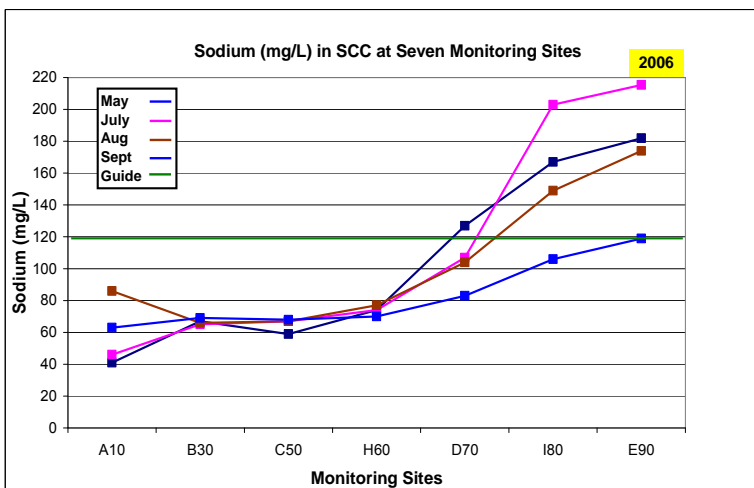
Figure 17: Sodium in Swift Current Creek in 2005

Figure 18: Sodium in Swift Current Creek in 2006

Figure 19: Sodium in Swift Current Creek in 2007

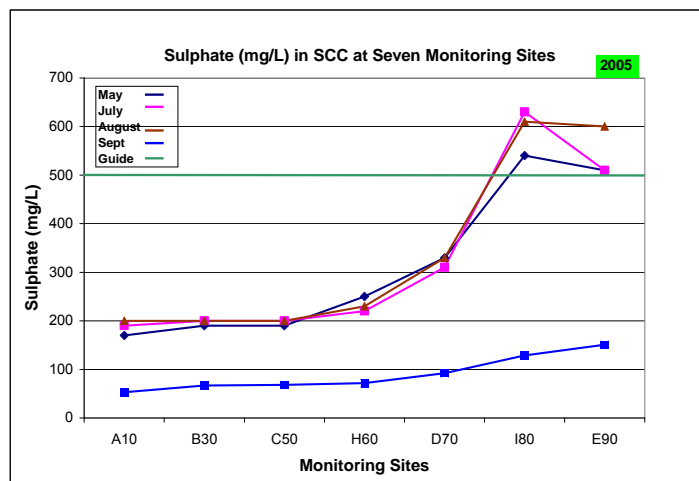
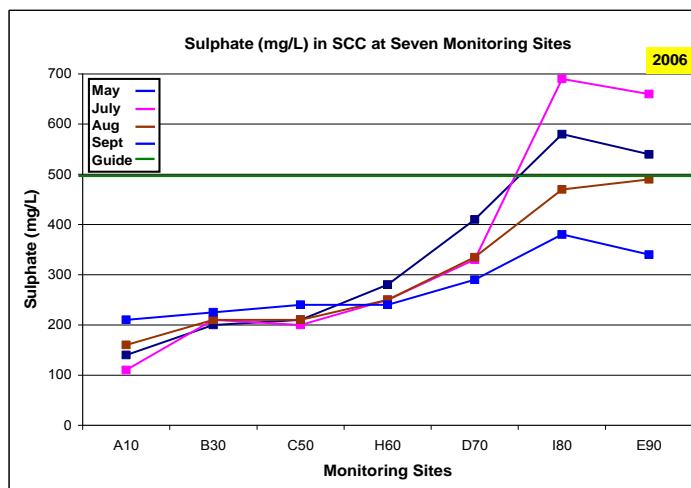
Figure 20: Sulfate in Swift Current Creek in 2005

Figure 21: Sulfate in Swift Current Creek in 2006

Figure 22: Sulfate in Swift Current Creek in 2007

Overall, the concentration of sulfate increases from upstream to downstream. In Figures 20, 21, and 22 sulfate remains below the acceptable guideline from site A10 to D70 throughout all three sample years. Water samples from sites I80 and E90 show sulfate levels above the acceptable guideline for at least two out of the four sample months. Sulfate is also present in groundwater springs that discharge into the SCC. These groundwater springs are present at both the I80 and E90 sample sites and are likely the main, if not sole, contributors to the sulfate levels in the creek downstream from Swift Current.

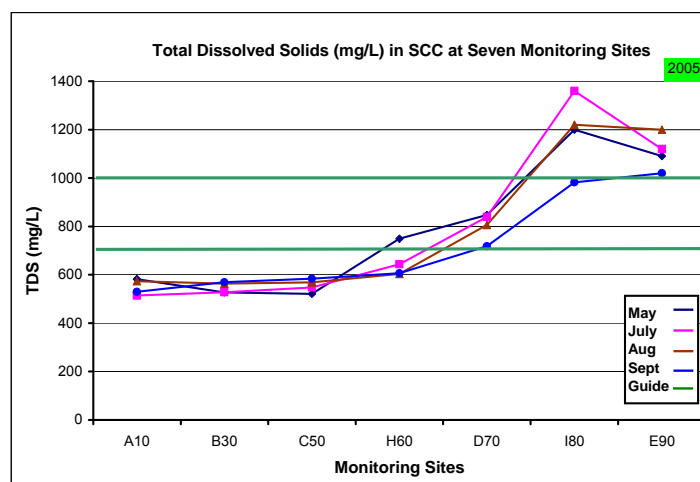
Figure 23: Total Dissolved Solids in Swift Current Creek in 2005

Figure 24: Total Dissolved Solids in Swift Current Creek in 2006

Figure 25: Total Dissolved Solids in Swift Current Creek in 2007

In SCC, the concentration of TDS increases from upstream to downstream. Total dissolved solids from site A10 to H60 are generally just below the acceptable lower guideline whereas TDS concentrations at I80 and E90 are above the upper guideline. The high TDS concentrations at I80 and E90 are likely a result of groundwater springs discharging into the creek. The springs contain a multitude of inorganic salts, leached out of the Bearpaw Shale, which contribute to high TDS levels. Two substances present in TDS, sodium and sulfate, show high values at both I80 and E90 sample sites. Although TDS may encompass many substances, it is likely that sodium and sulfate are the major contributors to the high TDS levels shown at I80 and E90 in all three sample years.

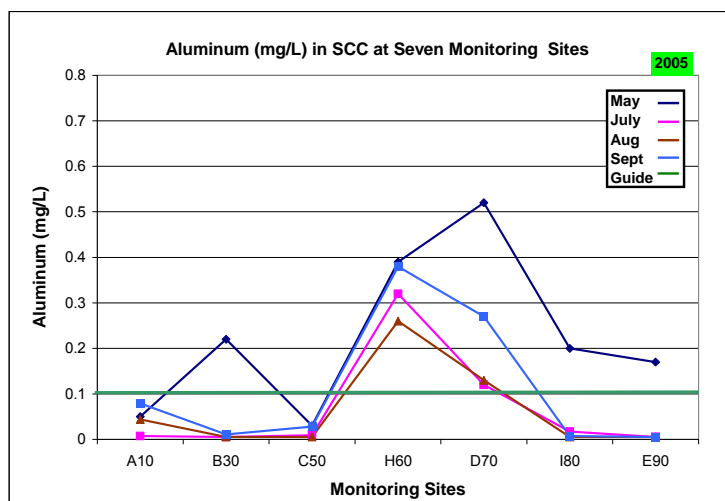
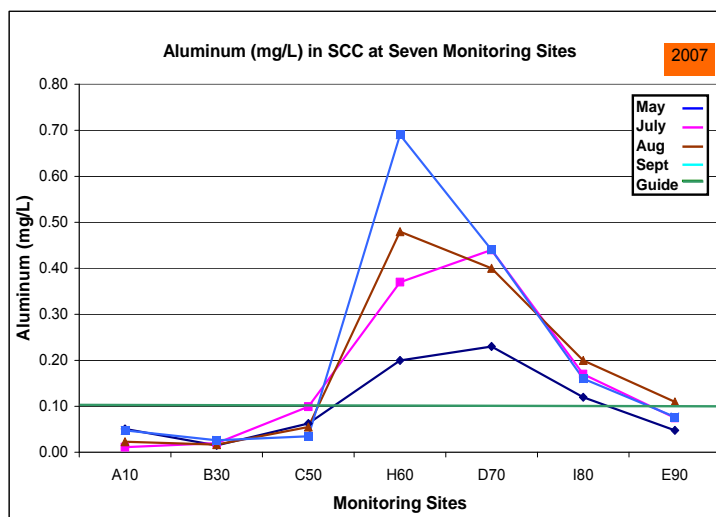
Figure 29: Aluminum levels in Swift Current Creek in 2005

Figure 30: Aluminum levels in Swift Current Creek in 2006

Figure 31: Aluminum levels in Swift Current Creek in 2007

Aluminum peaks at H60 in all three sample years. Site H60 is located within the City of Swift Current and is located downstream from the city's WTP. The repeated spike in aluminum may be attributed to the wash water released from the Swift Current WTP. Alum binds to potentially harmful microorganisms causing them to clump allowing easier removal from the water via sedimentation or filtration and is used in similar WTPs. However, the SCCWS can only speculate that the WTP may be contributing to the elevated aluminum levels in the creek without further investigation.
