## FENCING IS NOT THE ONLY SOLUTION

Using Off Site Watering Systems to Aid in Riparian Area Protection and Management

A report submitted to the Saskatchewan Ministry of Agriculture to promote the agriculture and food industry in Saskatchewan.

Swift Current Creek Watershed Stewards Inc.

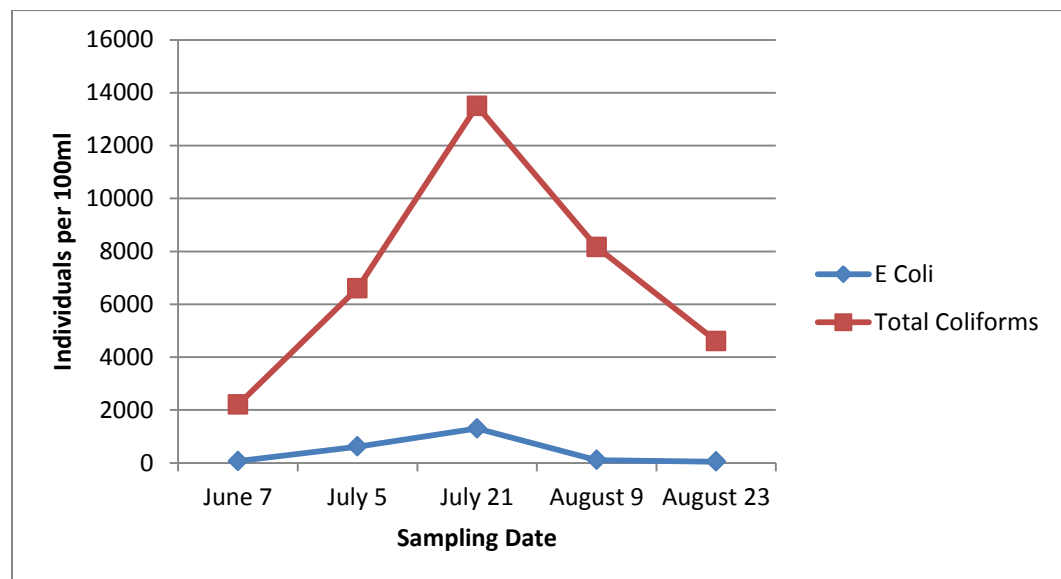
**Figure 1: E.coli & Total Coliform in individuals per 100ml for 2011**

In 2011, water samples were drawn on June 7<sup>th</sup>, July 5<sup>th</sup>, July 21<sup>st</sup>, August 9<sup>th</sup> and August 23<sup>rd</sup>. The sampling date for which the highest MPN/100mL was reported for both E. coli and total coliforms was July 21, 2011 (Figure1).

On this sampling date, *E. coli* were reported as 1300 individuals per 100 mL (1300/100mL) and total coliforms were reported as 13,500/100mL. Field data indicates that cattle were not present on site in 2011 until after this sampling date (Table 1).

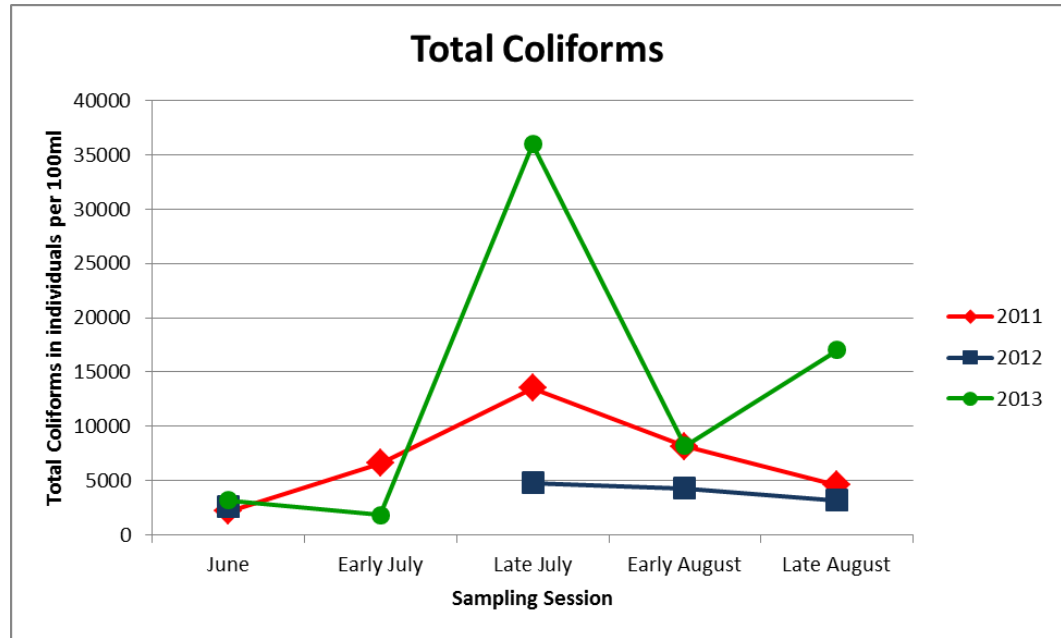
**Figure 5: Comparative Total Coliforms for all sampling years**

In 2013 E. coli was lowest on August 13<sup>th</sup>, with 200/100mL. Total coliforms were lowest on July 3<sup>rd</sup>, with 1800/100mL. In 2011 and 2012, E. coli and total coliforms declined to secondary lows at the end of the sampling season. In 2013, both parameters actually increase from early to late August, with total coliforms reaching a second unprecedented high for the entire three years of study on August 28th. (Figures 4 and 5)

Field records indicate that cattle were not present on site during this second period of increasing E.coli and total coliforms.

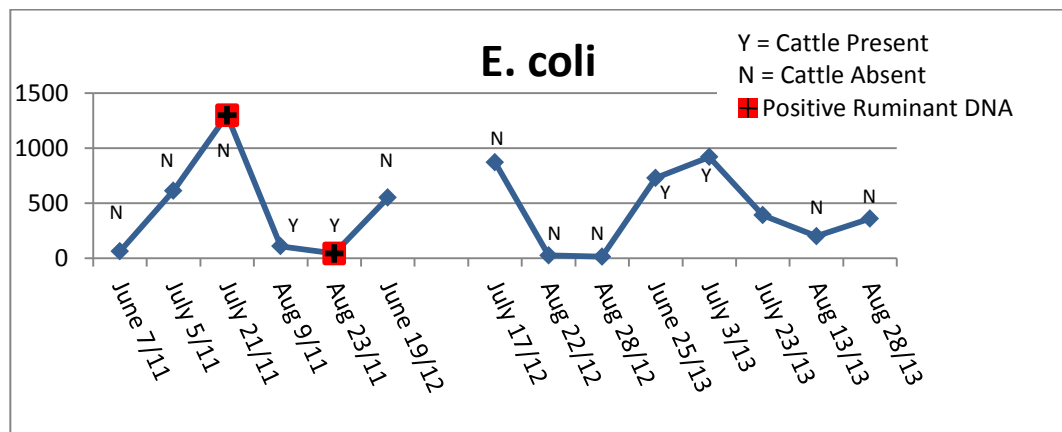
**Figure 6: E coli DNA Results with Absence and Presence of Cattle**

Figure 6 indicates that the DNA sample for July 21, 2011 showed positive for ruminant. The figure also shows that the cattle were not present on that day and the e coli levels were the highest of all the sampling periods at 1300/100ml. The only other positive for ruminant was on August 23, 2011 and on that date the cattle were present but the e coli was relatively low at 43/100 ml.

In July 2011 when the *e coli* was at the highest level it had ever been, the DNA results indicated a positive ruminant result and the cattle were not present. Thusly, when the *e coli* was at the second lowest level it had been the cattle were present and the DNA again showed that there was a positive for ruminant. We can expect the positive ruminant when the cattle are present but when they are not we could determine that the *ecoli* are from upstream practices.

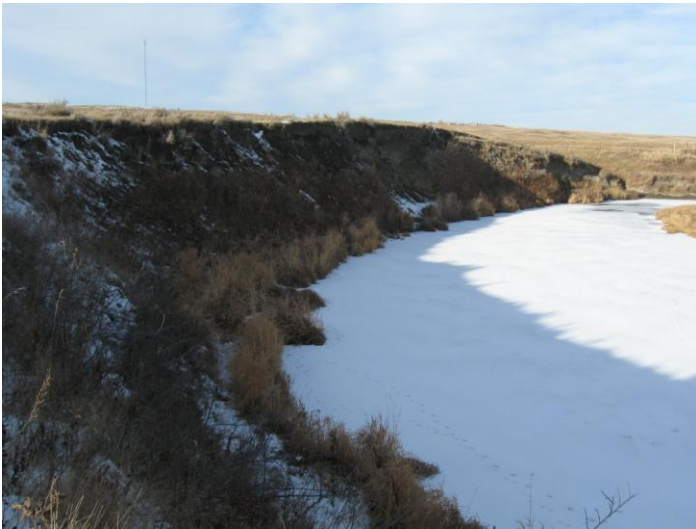
Photo 3: Down cutting and bare ground

- some bare ground at old water sites but looks good thru rest of the reach.  
- some cutting one bad spot at first meander east of the bridge

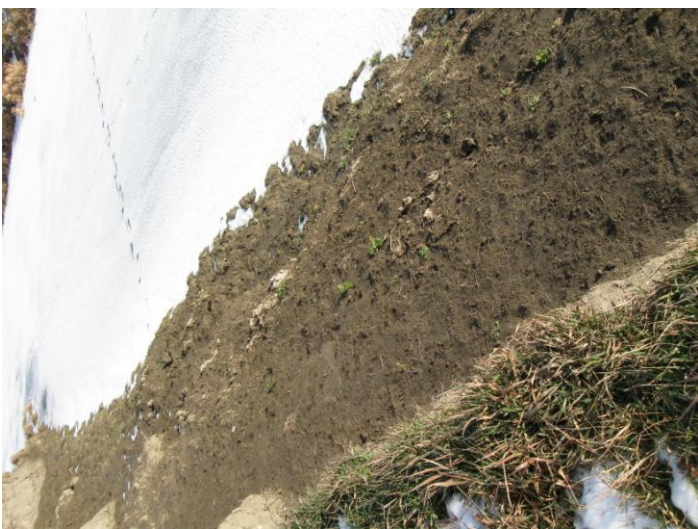
Photo 4: Bare ground visible at tip of photo #3

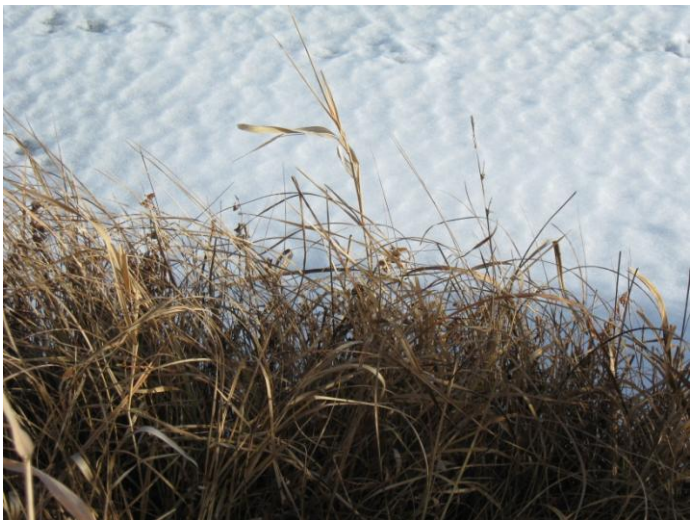
Photo 6: Good streambank protection

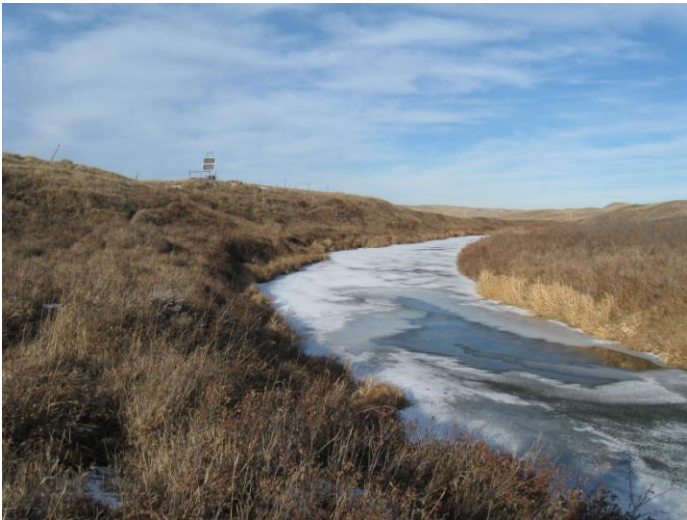
Photo 7: Off-site water system

- The project was set up on 160 acres of pasture which the Swift Current Creek flows through. 250 head of cattle graze this area using the creek as a water source. A watering system was purchased by the producer from a local supplier in November 2010 and was to be installed in the spring of 2011 prior to the grazing season. The system was not installed until the beginning of August 2011 as a result of unavailable parts. Once set up, the watering system was fenced off to prevent any damage from cattle. Cattle, which are usually present from July to August, were only present during the month of August in 2011. Water quality tests were completed five times during the growing season of 2011, 2012 and 2013: once in June, twice in July and twice in August. Circumstances resulted in the second sampling date being missed in 2012. The air temperature along with weather, water and riparian conditions were all noted on each sampling date. Due to the fast flow and a high level of water, the samples were taken within three feet of the bank. Water samples were collected, placed in a cooler with ice packs and shipped directly to Saskatchewan Research Council (SRC) for testing of e coli (Most Probable Number per 100 millilitres [MPN/100mL]) and total coliforms(MPN/100mL). When water was collected to send to SRC an extra bottle was collected, frozen and sent to the University of Regina for the DNA testing. In addition to field data and notes, results pertaining to water level (m) and discharge (m<sup>3</sup>/s) were obtained from the Government of Canada hydrometric station (Station 05HD036) just upstream from the project site. Finally, a riparian health assessment was completed on the site at the beginning of the project, on September 15<sup>th</sup>, 2010, and again at the end of 2013, on November 12<sup>th</sup>, 2013.*

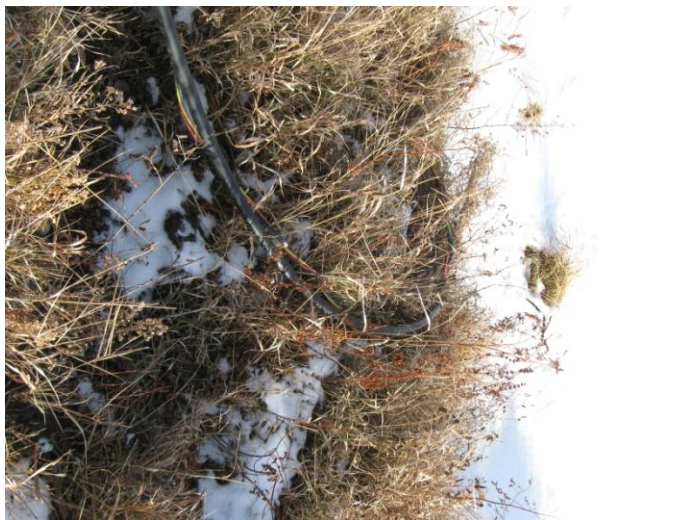
Photo 8: Intake

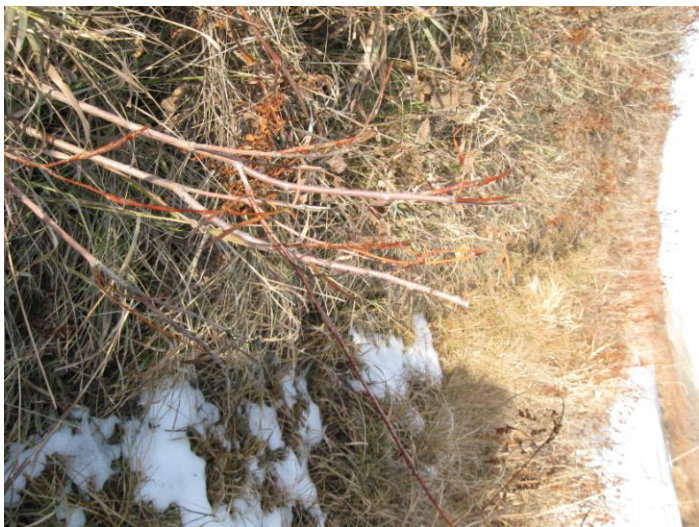
Photo 10: More young shrubs
